Case No. 2016-002118

City of Rock Hill, South Carolina, a Municipal Corporation, and South  
Carolina Department of Transportation, an agency of the State of South  
Carolina, Defendants,

RECORD ON APPEAL  
Volume III

| US Manhole<br><b>CB-01</b> | Total Length<br><b>149.2</b> | Material<br><b>Vitrified Clay Pipe</b> | Shape<br><b>Circular</b> | | I/I Value<br><b>N/A</b> | |

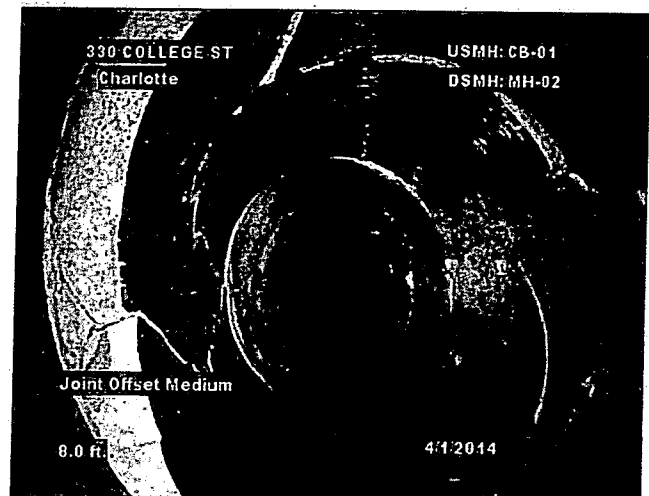
Distance: 8.0 ft. Grade: 1  
Condition: Joint Offset Medium  
Remarks: N/A

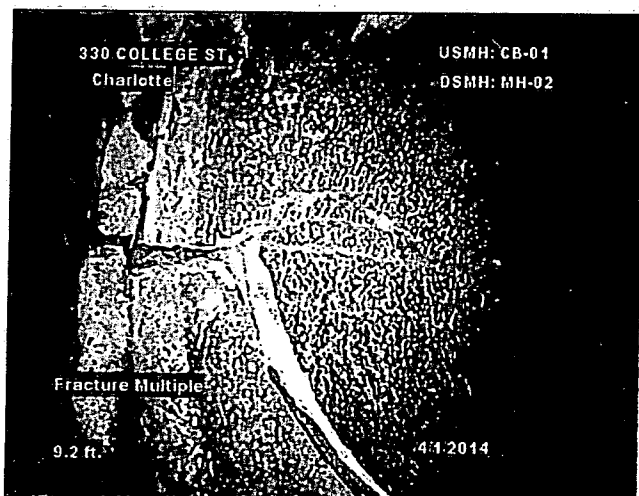
Distance: 9.2 ft. Grade: 4  
Condition: Fracture Multiple  
Remarks: N/A

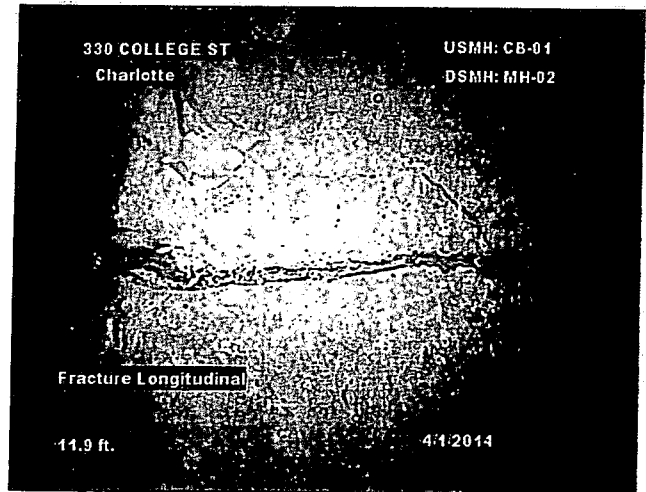
Distance: 11.9 ft. Grade: 3  
Condition: Fracture Longitudinal  
Remarks: N/A

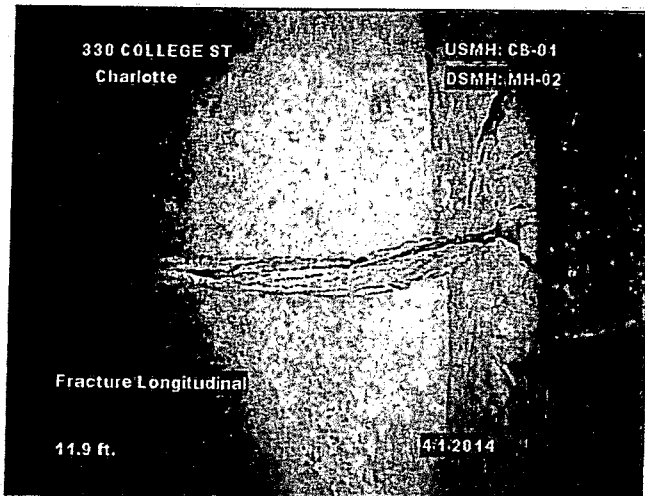
Distance: 11.9 ft. Grade: 3  
Condition: Fracture Longitudinal  
Remarks: N/A

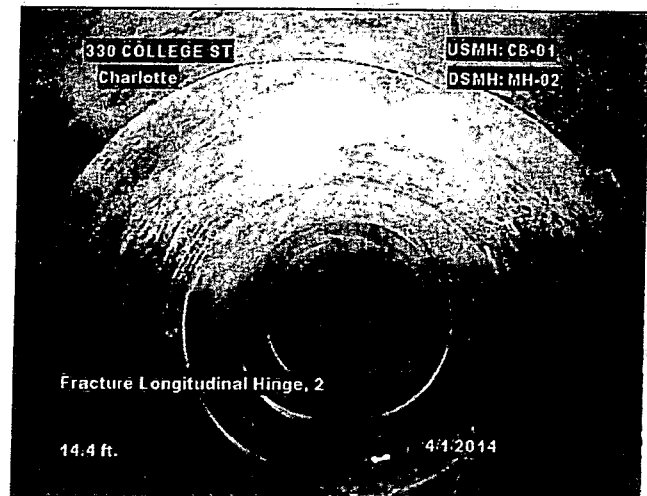
Distance: 14.4 ft. Grade: 4  
Condition: Fracture Longitudinal Hinge, 2  
Remarks: N/A

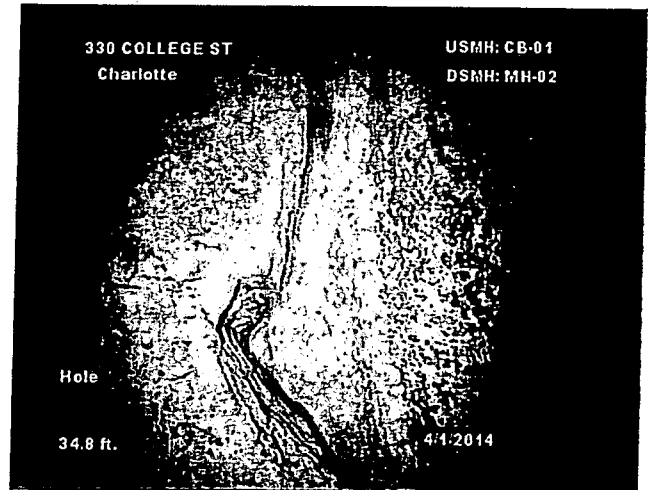
Distance: 34.8 ft. Grade: 3  
Condition: Hole  
Remarks: N/A

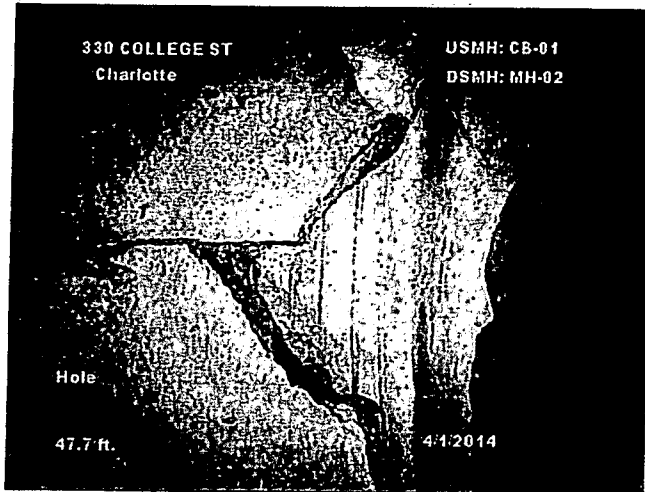
Distance: 47.7 ft. Grade: 3  
Condition: Hole  
Remarks: N/A

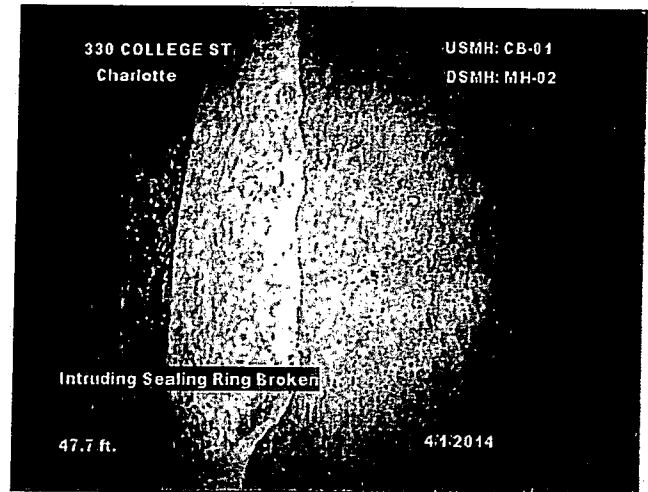
Distance: 47.7 ft. Grade: 3  
Condition: Intruding Sealing Ring Broken  
Remarks: N/A

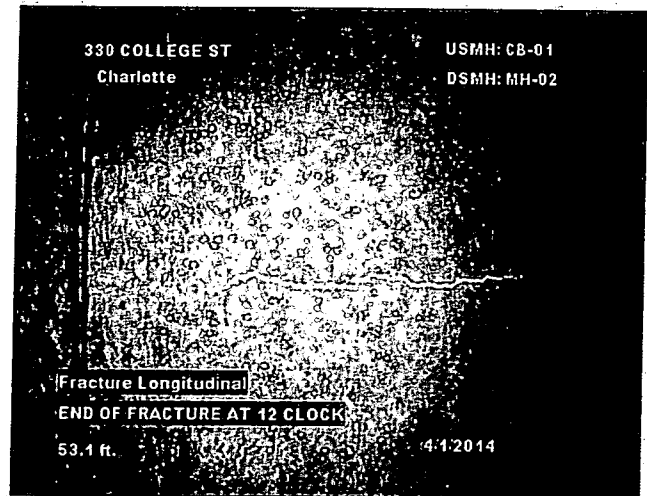
Distance: 53.1 ft. Grade: 3  
Condition: Fracture Longitudinal  
Remarks: END OF FRACTURE AT 12 O'CLOCK

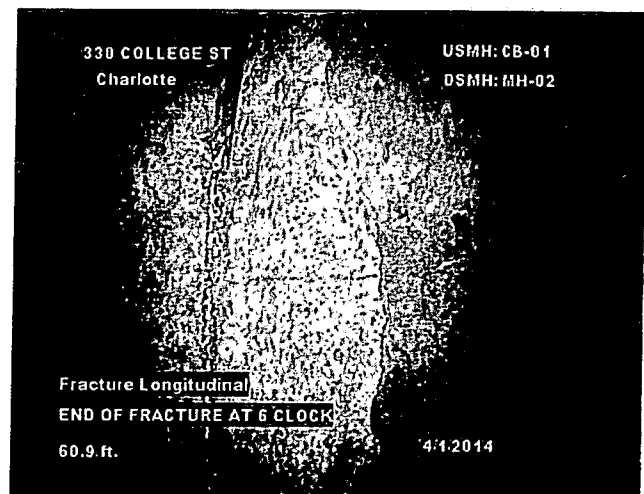
Distance: 60.9 ft. Grade: 3  
Condition: Fracture Longitudinal  
Remarks: END OF FRACTURE AT 6 O'CLOCK

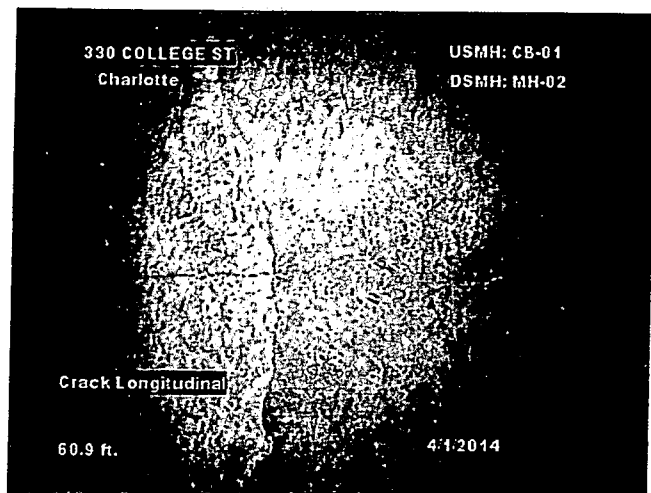
Distance: 60.9 ft. Grade: 2  
Condition: Crack Longitudinal  
Remarks: N/A

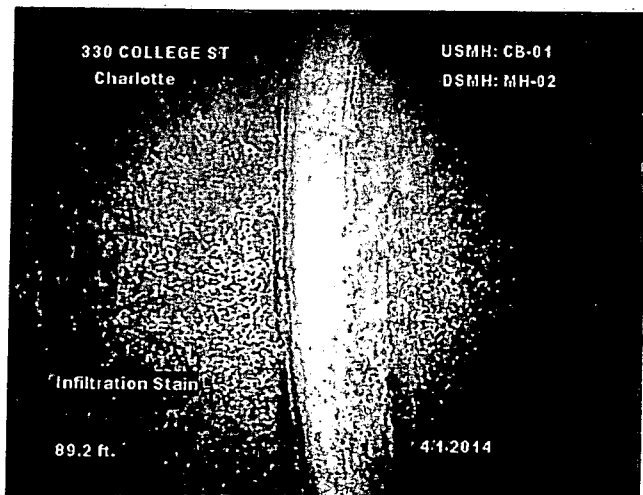
Distance: 89.2 ft. Grade: 0  
Condition: Infiltration Stain  
Remarks: N/A

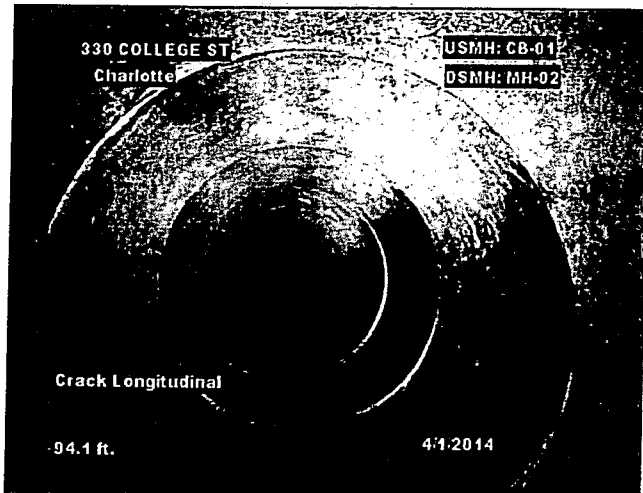
Distance: 94.1 ft. Grade: 2  
Condition: Crack Longitudinal  
Remarks: N/A

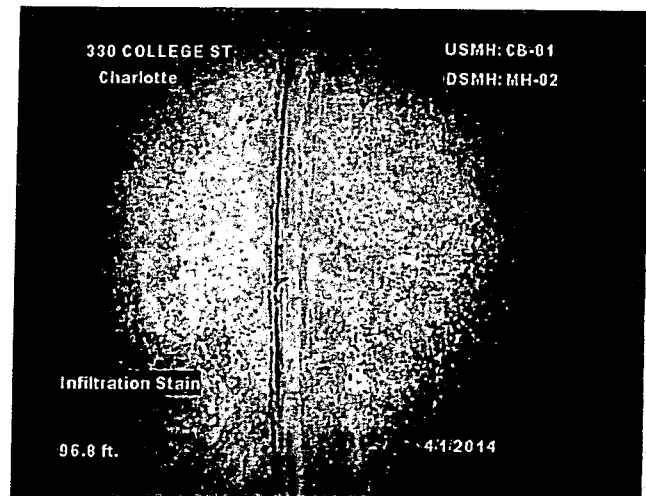
Distance: 96.8 ft. Grade: 0  
Condition: Infiltration Stain  
Remarks: N/A

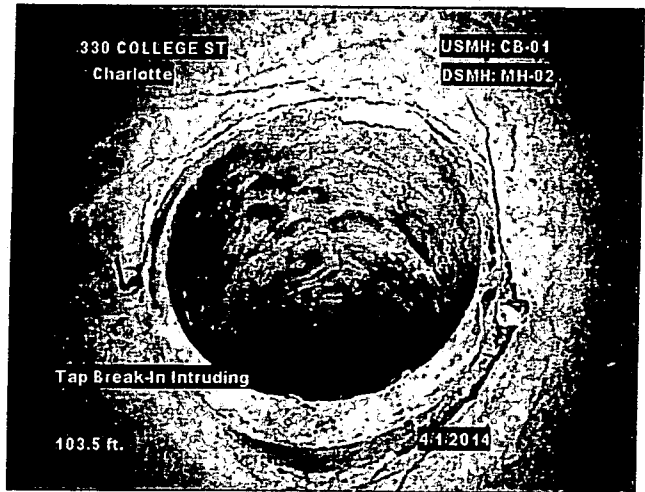
Distance: 103.5 ft. Grade: 2  
Condition: Tap Break-In Intruding  
Remarks: N/A

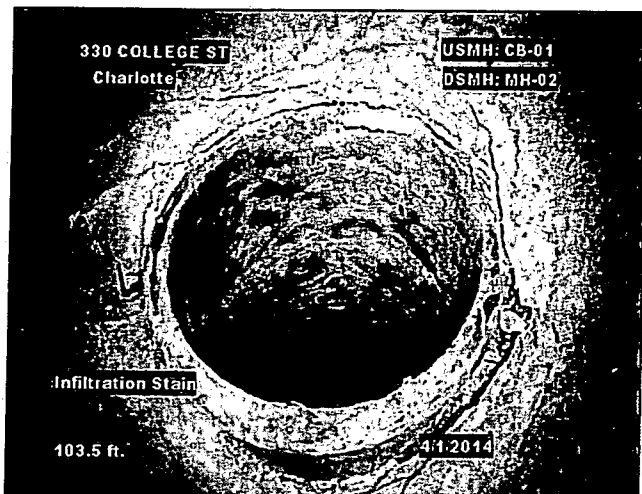
Distance: 103.5 ft. Grade: 0  
Condition: Infiltration Stain  
Remarks: N/A

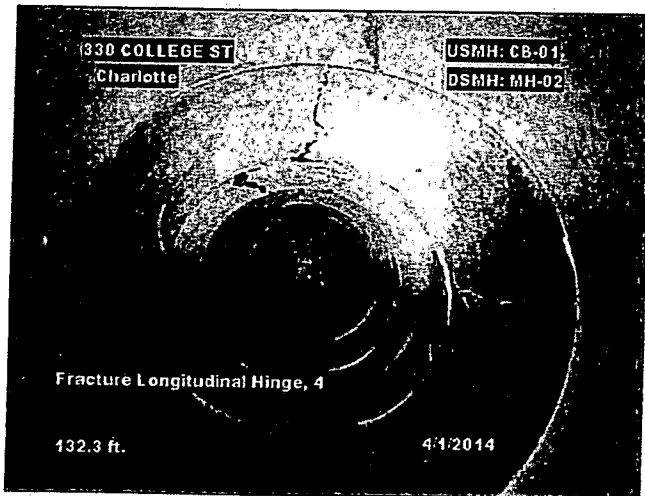
Distance: 132.3 ft. Grade: 5  
Condition: Fracture Longitudinal Hinge, 4  
Remarks: N/A

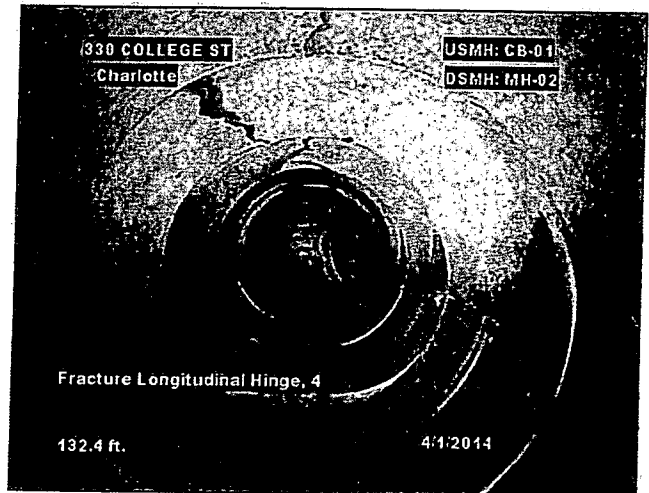
Distance: 132.4 ft. Grade: 5  
Condition: Fracture Longitudinal Hinge, 4  
Remarks: N/A

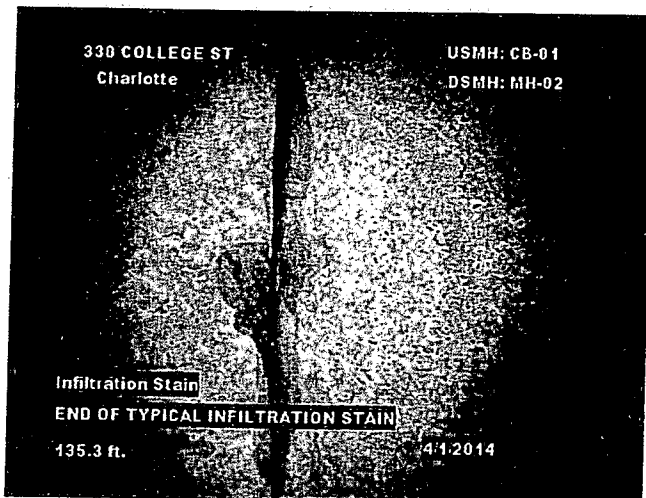
Distance: 135.3 ft. Grade: 0  
Condition: Infiltration Stain  
Remarks: END OF TYPICAL INFILTRATION STAIN

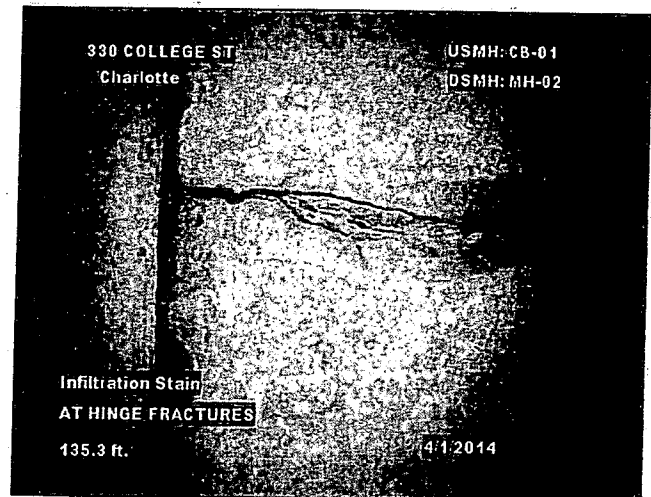
Distance: 135.3 ft. Grade: 0  
Condition: Infiltration Stain  
Remarks: AT HINGE FRACTURES

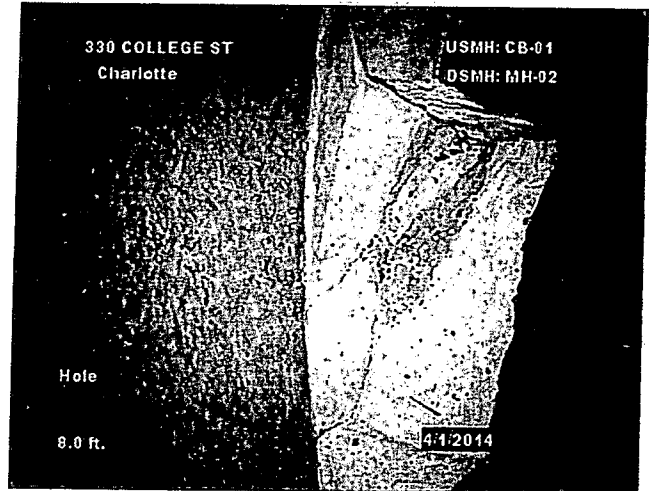
Distance: 8.0 ft. Grade: 3  
Condition: Hole  
Remarks: N/A

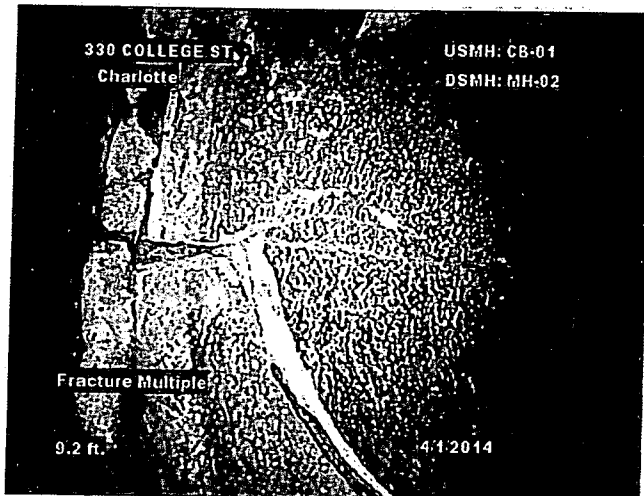
Distance: 9.2 ft. Grade: 4  
Condition: Fracture Multiple  
Remarks: N/A

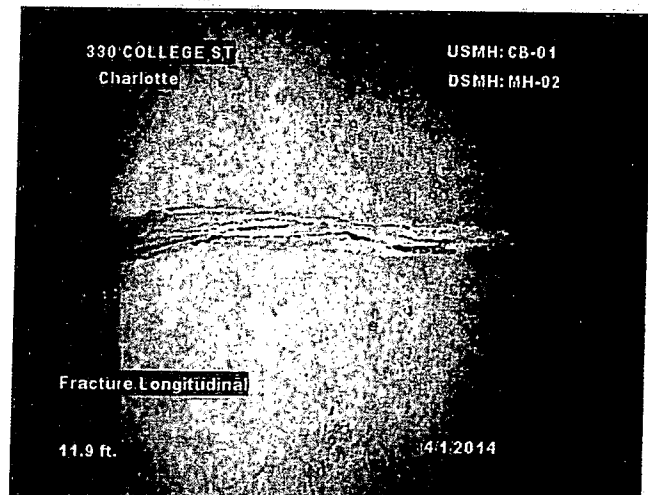
Distance: 11.9 ft. Grade: 3  
Condition: Fracture Longitudinal  
Remarks: N/A

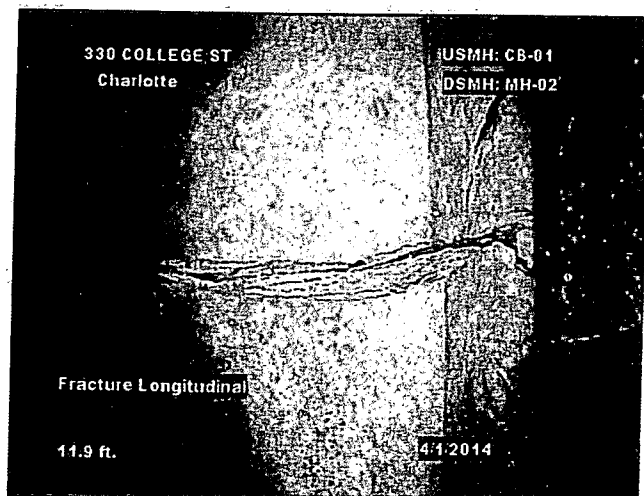
Distance: 11.9 ft. Grade: 3  
Condition: Fracture Longitudinal  
Remarks: N/A

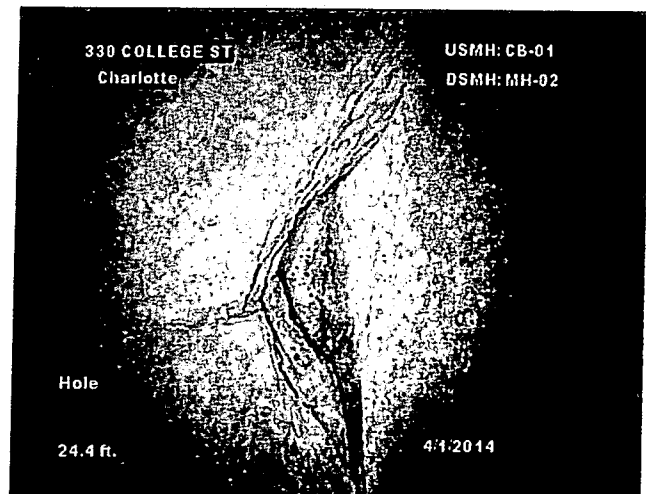
Distance: 24.4 ft. Grade: 3  
Condition: Hole  
Remarks: N/A

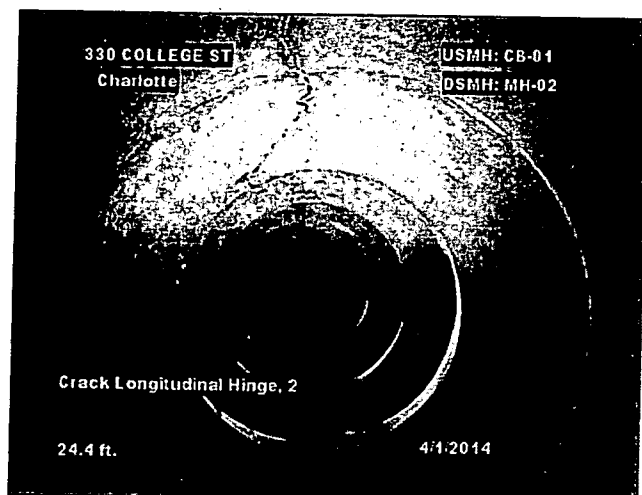
Distance: 24.4 ft. Grade: 4  
Condition: Crack Longitudinal Hinge, 2  
Remarks: N/A

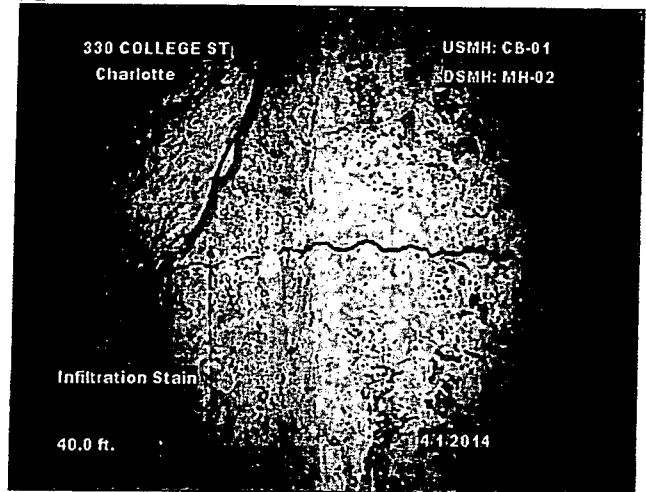
Distance: 40.0 ft. Grade: 0  
Condition: Infiltration Stain  
Remarks: N/A

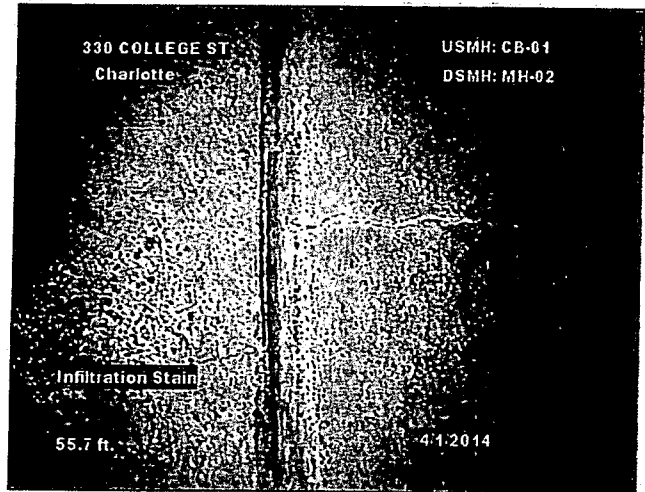
Distance: 55.7 ft. Grade: 0  
Condition: Infiltration Stain  
Remarks: N/A

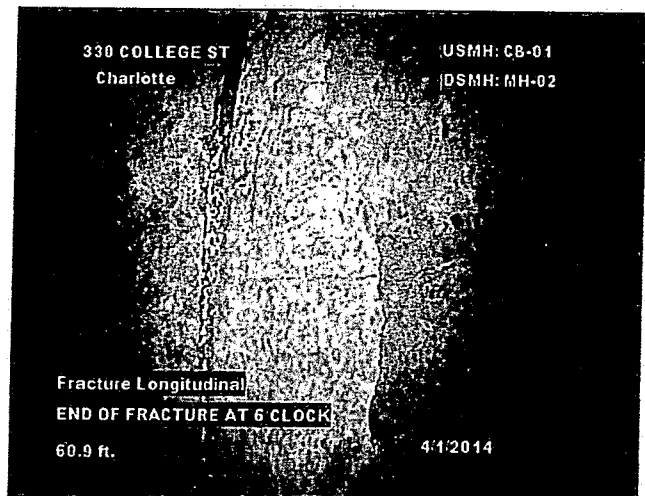
Distance: 60.9 ft. Grade: 3  
Condition: Fracture Longitudinal  
Remarks: END OF FRACTURE AT 6 O'CLOCK

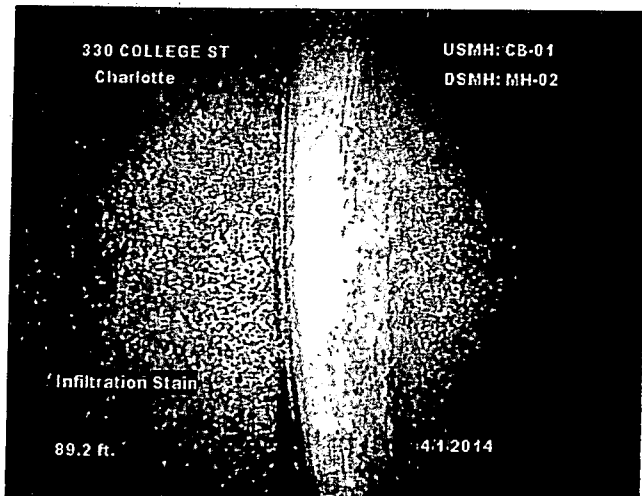
Distance: 89.2 ft. Grade: 0  
Condition: Infiltration Stain  
Remarks: N/A

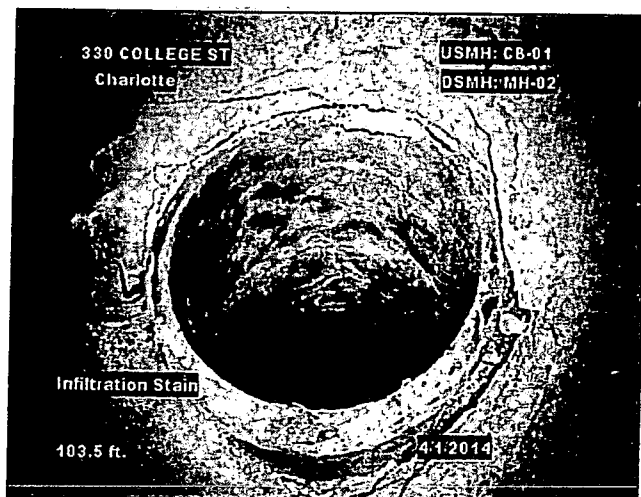
Distance: 103.5 ft. Grade: 0  
Condition: Infiltration Stain  
Remarks: N/A

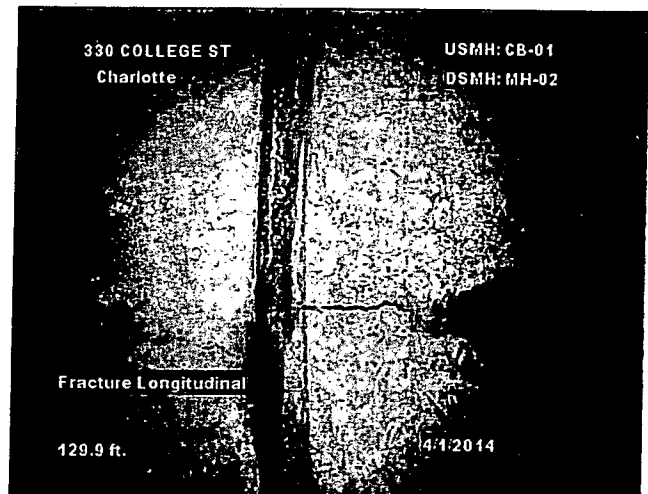
Distance: 129.9 ft. Grade: 3  
Condition: Fracture Longitudinal  
Remarks: N/A

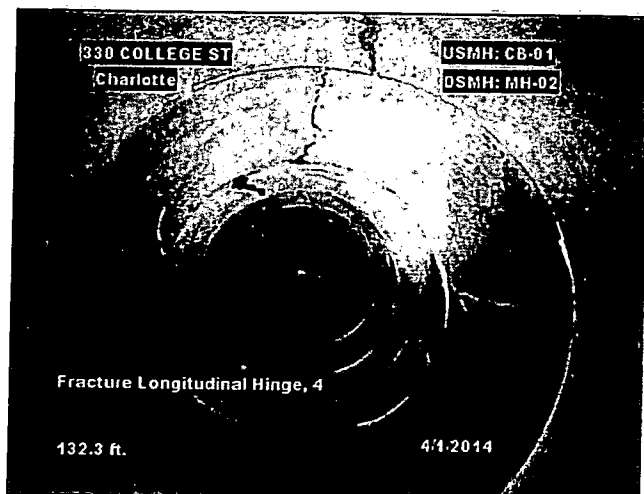
Distance: 132.3 ft. Grade: 5  
Condition: Fracture Longitudinal Hinge, 4  
Remarks: N/A

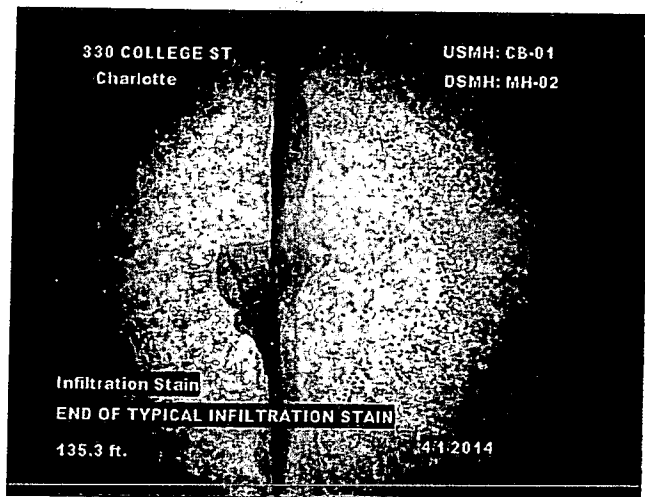
Distance: 135.3 ft. Grade: 0  
Condition: Infiltration Stain  
Remarks: END OF TYPICAL INFILTRATION STAIN

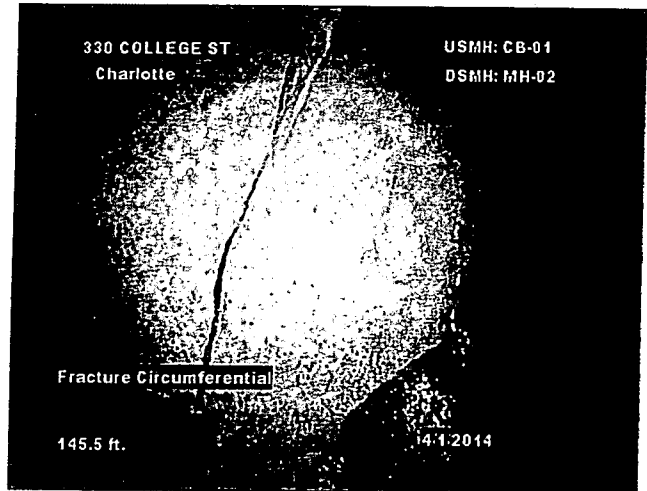
Distance: 145.5 ft. Grade: 2  
Condition: Fracture Circumferential  
Remarks: N/A

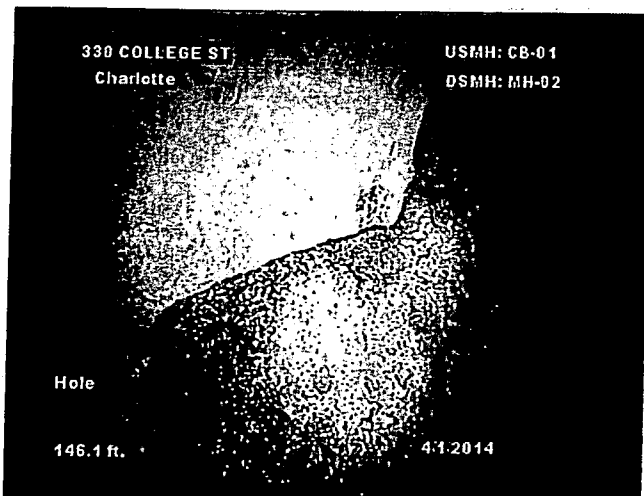
Distance: 146.1 ft. Grade: 3  
Condition: Hole  
Remarks: N/A
