THE STATE OF SOUTH CAROLINA
In The Court of Appeals.

RECORD ON APPEAL
Volume III

September 17, 2015 Affidavit of Michael H. Leonard and Correction to Affidavit of Michael H. Leonard.....	922
Appellant's October 12, 2016 Notice of Appeal	980

3. I am certain from the evidence that I have seen that the pipe which runs beneath Ms. Ray's house is leaking. The most conclusive evidence of this is a report generated by Bio-Nomic Services which was generated in connection with a video we had shot of the line in April, 2004. It reaffirms what I suspected. The pipe is old, and cannot do the job it is being forced to do. I have attached the Bio-Nomic Report as Exhibit 1.

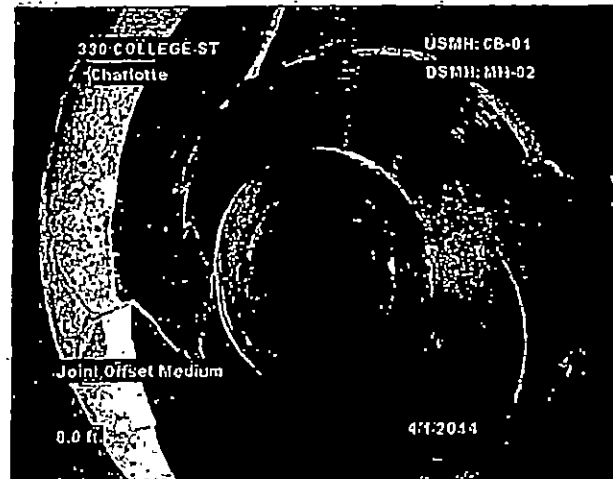
Distance: 8.0 ft. Grade: 1
 Condition: Joint Offset Medium
 Remarks: N/A

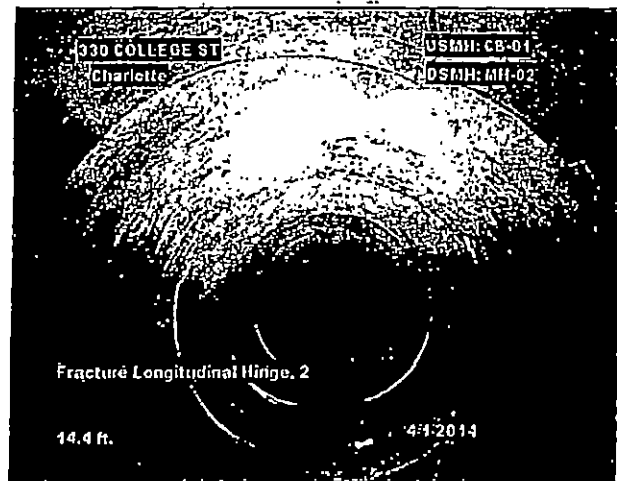
Distance: 14.4 ft. Grade: 4
 Condition: Fracture Longitudinal Hinge, 2
 Remarks: N/A

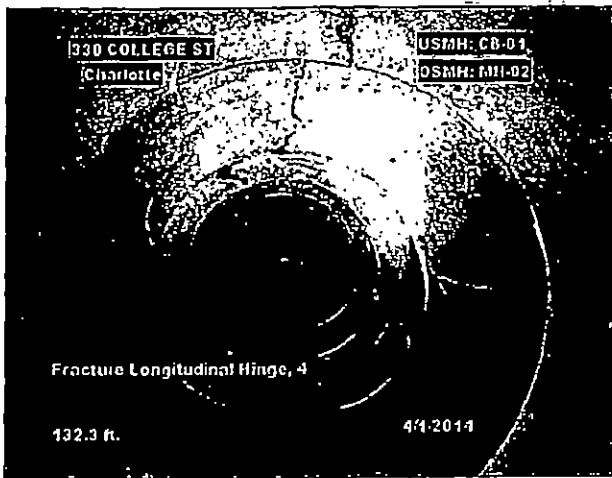
Distance: 132.3 ft. Grade: 5'
 Condition: Fracture Longitudinal Hinge, 4
 Remarks: N/A

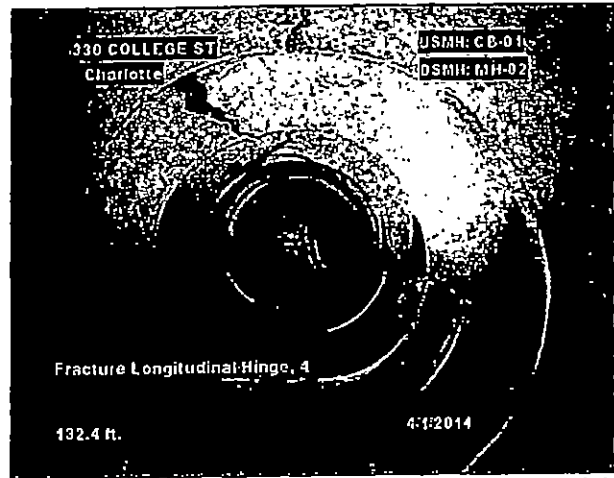
Distance: 132.4 ft. Grade: 5'
 Condition: Fracture Longitudinal Hinge, 4
 Remarks: N/A
