**REPLY BRIEF OF APPELLANT
(HOME INSPECTION ONE, LLC)**

Home Inspection Report

901 Valhalla
Columbia, SC

4-3-19

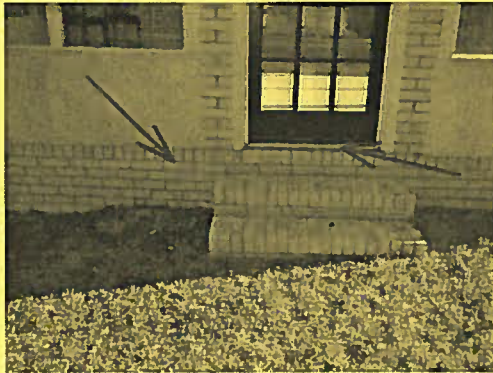
Stress crack and gap under door

5. Differential Movement: - Stress cracks in brick veneer above front steps, below and above back sunroom door. On L wall of garage.
A licensed contractor or foundation company is recommended to further evaluate all of structure and repair.

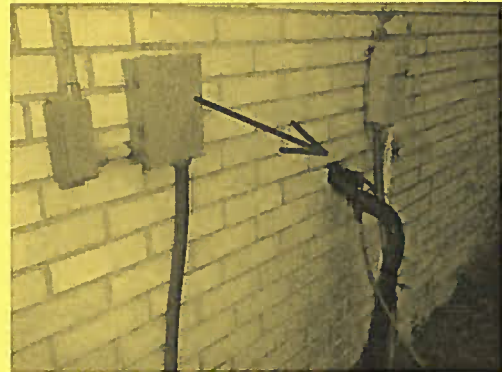
Wall penetrations are not sealed

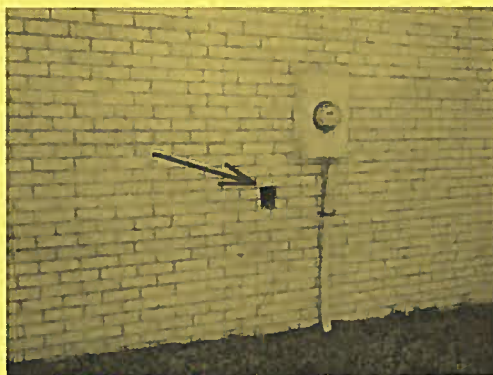
Wall penetrations are not sealed, several of these

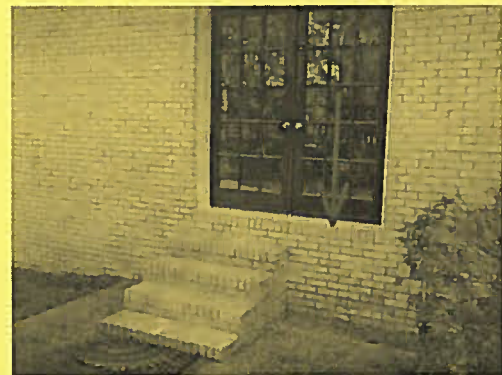
Master bedroom back doors are missing handrailing and one door opens without steps or landing below

Door on L open to outside without a landing or steps.
Hand railing is also missing from master steps. |

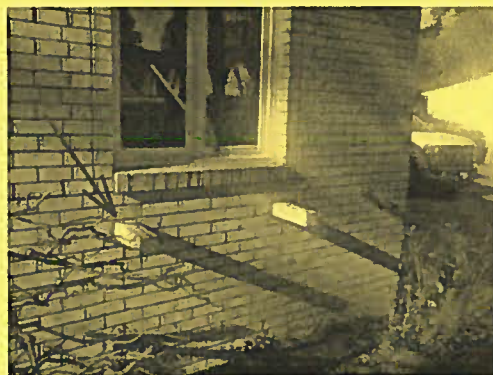
Windowsill on R front has water damaged.
Deco woodpost are loose in wall

1. Trim/Fascia/Soffits - Window sill on R front has water damage/soft wood.
Wood post sticking out of brick veneer under all front windows are loose.
A licensed contractor is recommended to further evaluate and all siding and trim and repair.
2. Entry Doors: - Master bedroom backdoors will not close/latch/seal properly.
Door on L open to outside without a landing or steps.
Hand railing is also missing from master steps.
Back sunroom door is missing sweep/weather stripping.
A qualified contractor is recommended to evaluate and repair
- * (3) Other: - Wall penetrations/openings at HVAC lines and plumbing clean-outs are not sealed *

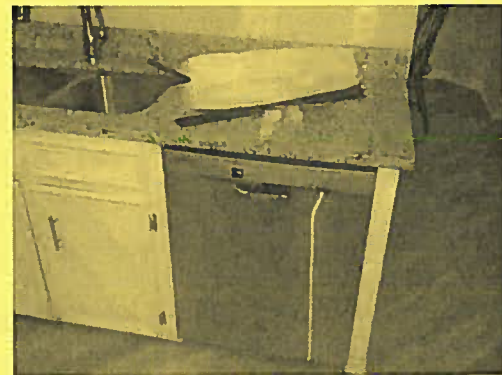
Some of the dishwasher parts have not been installed

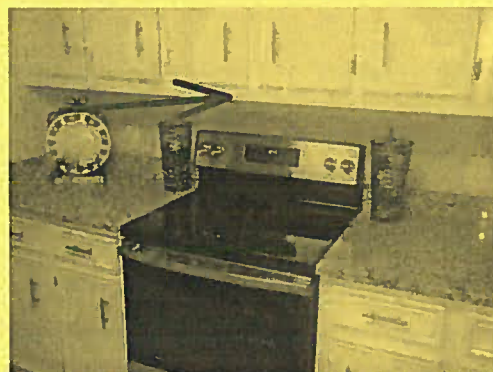
Low clearance above stove, 30in to combustibles required.

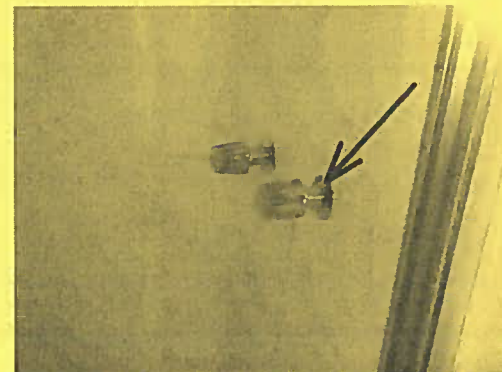
Master shower valve stems are leaking

11. Master Bathroom Shower/Surround: - Valve stems are leaking

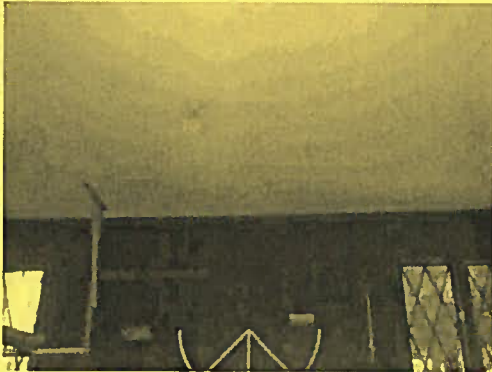
Ceiling texture loose and peeling in garage, not due to leaks

4. Front Garage Ceiling: - Popped seams or loose seam tape, no visible signs of leaks or other damage.

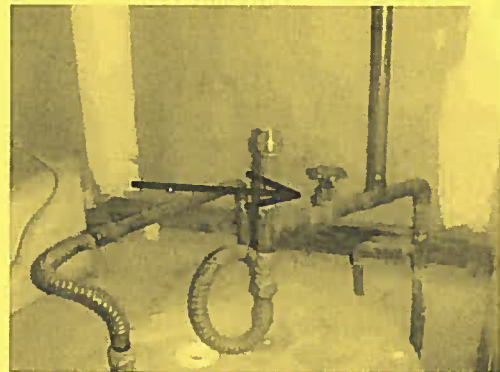
Valve at top of water heater is leaking

- (10) Water Lines: - Supply valve at above water heater is leaking.
A licensed plumber is recommended to further evaluate all plumbing and repair.

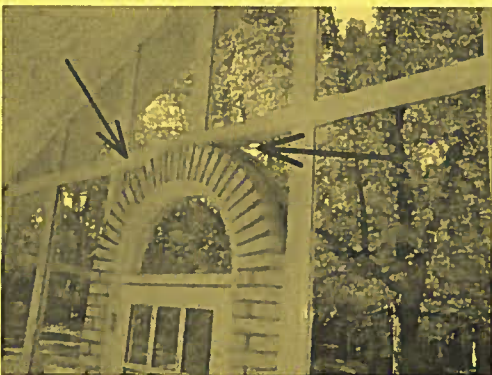
Broken glass on R and both sections are not sealed

- 17. Main Living Space Windows: - One of the two small windows above sunroom backdoor is broken and neither are sealed.
- 18. Main Living Space Electrical: - Wall outlet not working, R wall in R front bedroom

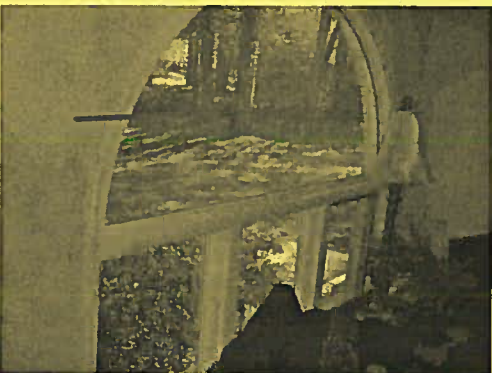
Insulated glass seal has failed (glass fogged)

15. Main Living Space Windows: - Windows stuck/ painted/ secured shut, could not get any to operate/open.
16. Main Living Space Windows: - Insulated glass seals have failed/ glass fogged. Recommend having all windows checked when repairs are made. Noted on window in L front bedroom and one in living room, & possibly others.

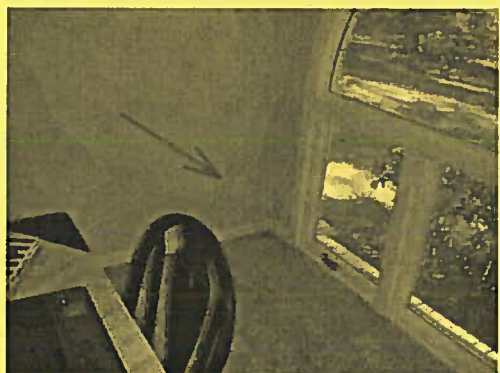
This wall outlet is not working

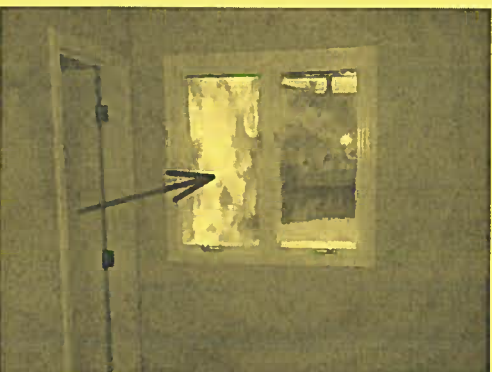
Insulated glass seal has failed (glass fogged)

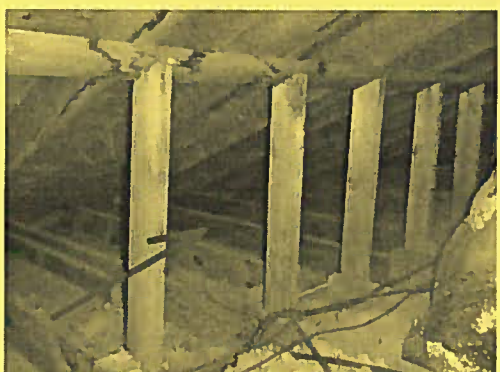
No insulation present in rear of attic

Insulation: - No insulation present in area above back sliding door (old porch) and on vertical wall where mini split mounted.
Chase at chimney in attic is open/not sealed.
A qualified contractor is recommended to evaluate and repair.
7.

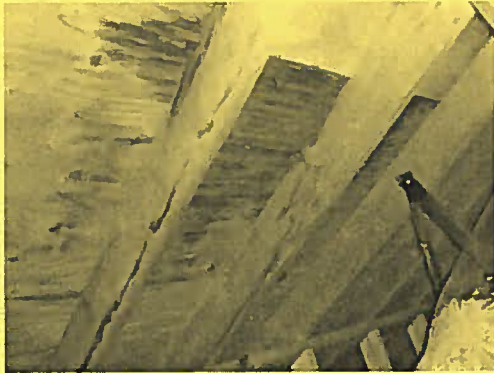
Dry stains in attic, possibly old, confirm all leaks have been repaired

Moisture Penetration: - Moisture stains visible, tested dry, possibly old, confirm all leaks have been repaired.
12.

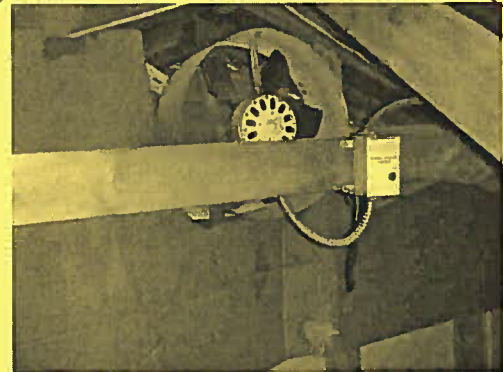
Motors are burned out in attic vent fans (both units)

Attic Fan: - Motors are burned out, both units.
9.

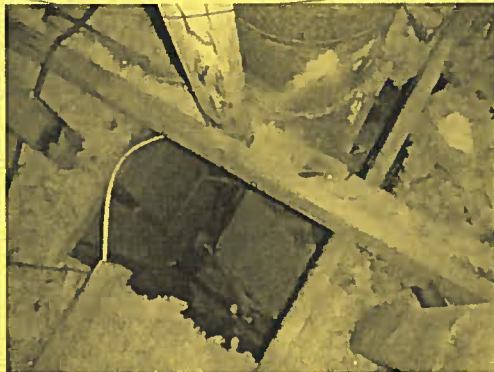
Rust on fireplace box and flue from previous leaks.
Open area (chase) around fireplace is not sealed

Fireplace Construction: - Metal firebox and flue have areas of rust and has started rusting out in some areas.
Visible in den and in from attic.
A licensed contractor is recommended to further evaluate and repair.
3. Type: Wood burning
4.

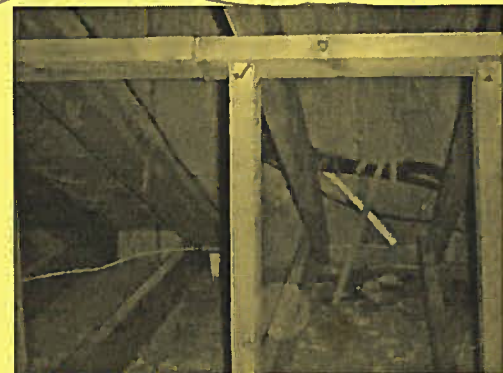
Vertical wall in sunroom is missing insulation

- * (6) Main Attic Insulation: - No insulation present in area above back sliding door (old porch) and on vertical wall where mini split is mounted.
Chase at chimney in attic is open/not sealed.
A qualified contractor is recommended to evaluate and repair.
- * (7) Main Attic Attic Fan: - Motors are burned out, both units.
- * (8) Main Attic Moisture Penetration: - Moisture stains visible, tested dry, possibly old, confirm all leaks have been repaired.

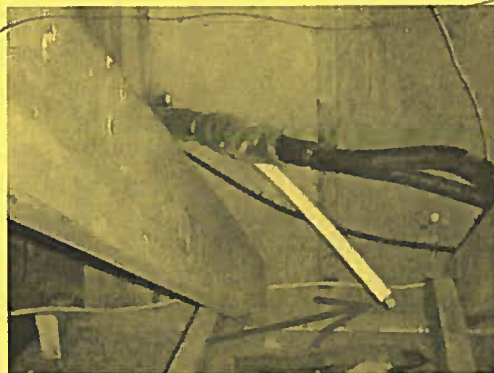
Appears installation is not complete for sunroom mini split system.

- 19. Mini Split System AC System A/C System Operation: - Installation is not complete.
A qualified air conditioning contractor is recommended to evaluate and repair

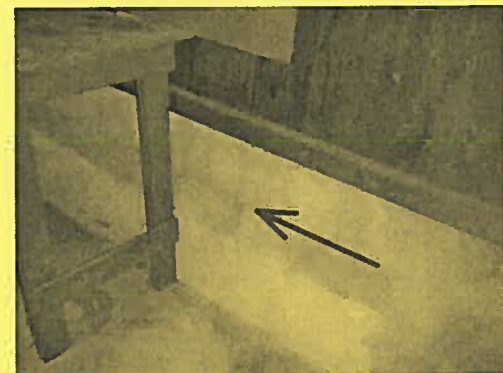
Stress crack in block wall of garage
