**REPLY BRIEF OF APPELLANT  
(SUNSETTER PROPERTIES, LLC)**

# Home Inspection Report

901 Valhalla  
Columbia, SC

4-3-19

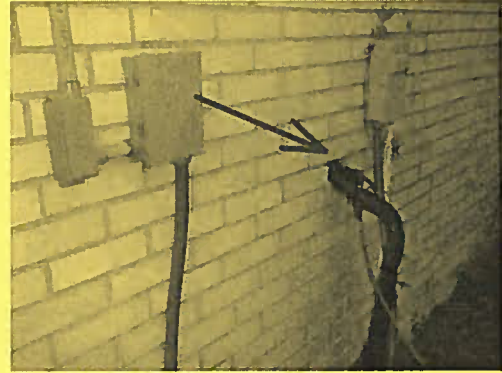
Wall penetrations are not sealed

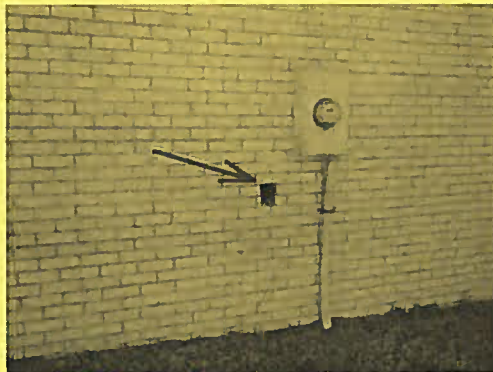
Wall penetrations are not sealed, several of these

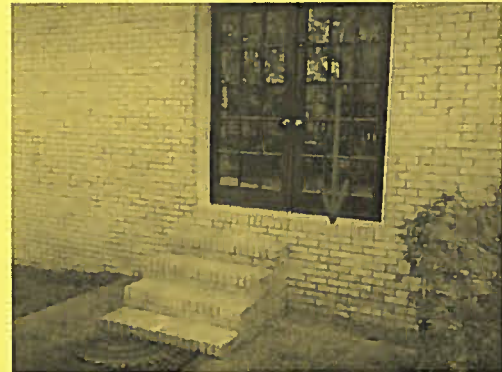
Master bedroom back doors are missing handrailing and one door opens without steps or landing below

| 3. | <input type="checkbox"/> | <input type="checkbox"/> | <input type="checkbox"/> | <input type="checkbox"/> | <input checked="" type="checkbox"/> | Entry Doors: - Master bedroom backdoors will not close/latch/seal properly.<br>Door on L open to outside without a landing or steps.<br>Hand railing is also missing from master steps. |

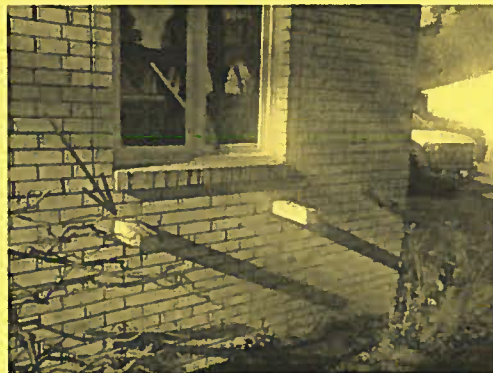
Windowsill on R front has water damaged.  
Deco woodpost are loose in wall

1. Trim/Fascia/Soffits - Window sill on R front has water damage/soft wood.  
Wood post sticking out of brick veneer under all front windows are loose.  
A licensed contractor is recommended to further evaluate and all siding and trim and repair.
2. Entry Doors: - Master bedroom backdoors will not close/latch/seal properly.  
Door on L open to outside without a landing or steps.  
Hand railing is also missing from master steps.  
Back sunroom door is missing sweep/weather stripping.  
A qualified contractor is recommended to evaluate and repair
- \* (3) Other: - Wall penetrations/openings at HVAC lines and plumbing clean-outs are not sealed \*

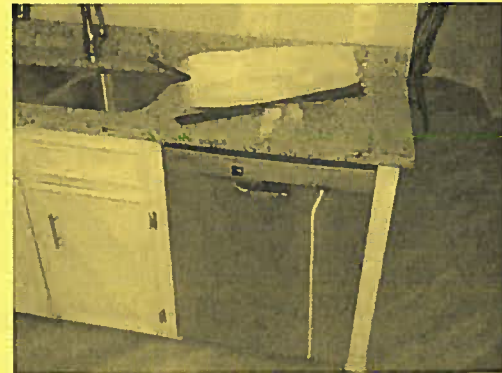
Some of the dishwasher parts have not been installed

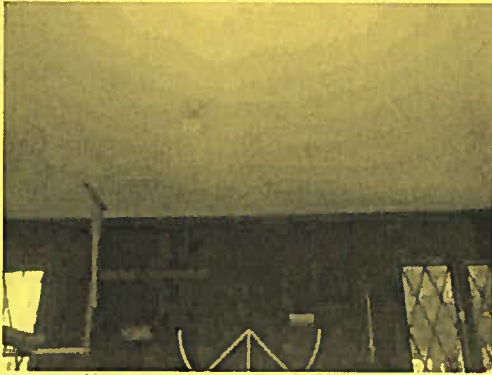
Ceiling texture loose and peeling in garage, not due to leaks

4. Front Garage Ceiling: - Popped seams or loose seam tape, no visible signs of leaks or other damage.

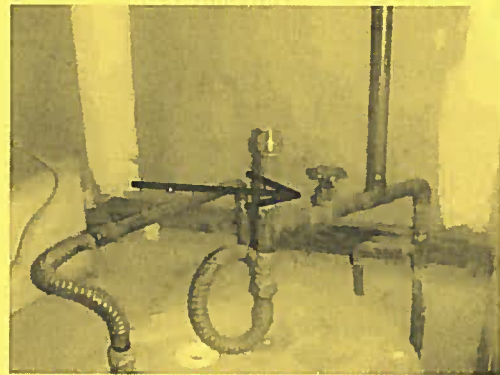
Valve at top of water heater is leaking

- (10) Water Lines: - Supply valve at above water heater is leaking.  
A licensed plumber is recommended to further evaluate all plumbing and repair.

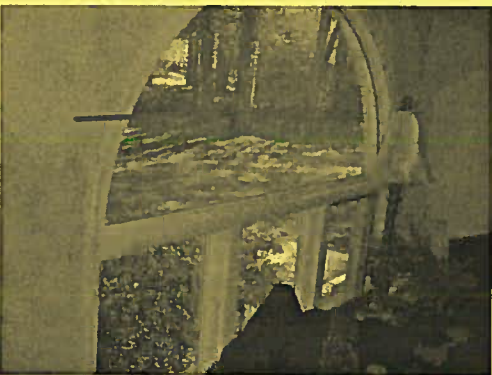
Insulated glass seal has failed (glass fogged)

15. Main Living Space Windows: - Windows stuck/ painted/ secured shut, could not get any to operate/open.
16. Main Living Space Windows: - Insulated glass seals have failed/ glass fogged. Recommend having all windows checked when repairs are made. Noted on window in L front bedroom and one in living room, & possibly others.

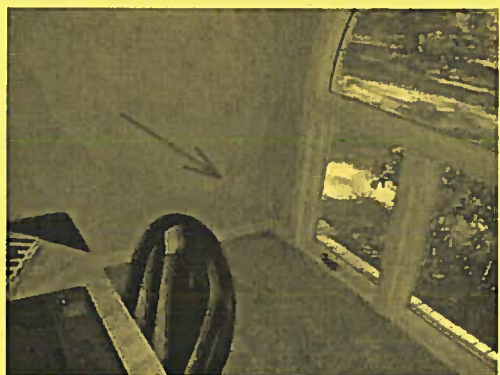
This wall outlet is not working

- 17. Main Living Space Windows: - One of the two small windows above sunroom backdoor is broken and neither are sealed.
- 18. Main Living Space Electrical: - Wall outlet not working, R wall in R front bedroom

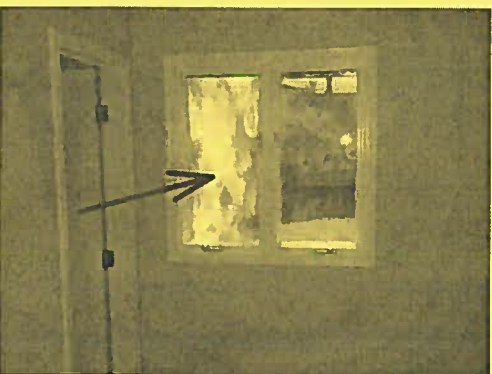
Insulated glass seal has failed (glass fogged)

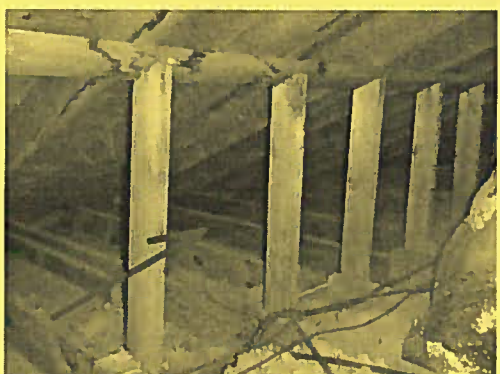
No insulation present in rear of attic

Insulation: - No insulation present in area above back sliding door (old porch) and on vertical wall where mini split mounted.  
Chase at chimney in attic is open/not sealed.  
A qualified contractor is recommended to evaluate and repair.
7.

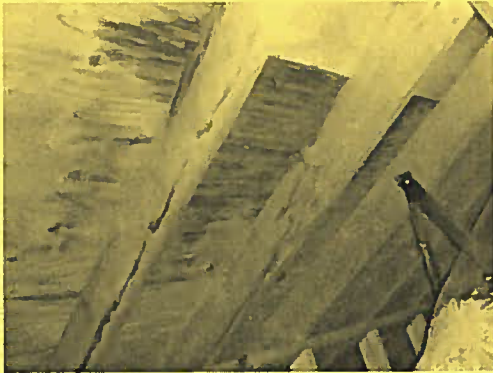
Dry stains in attic, possibly old, confirm all leaks have been repaired

Moisture Penetration: - Moisture stains visible, tested dry, possibly old, confirm all leaks have been repaired.
12.

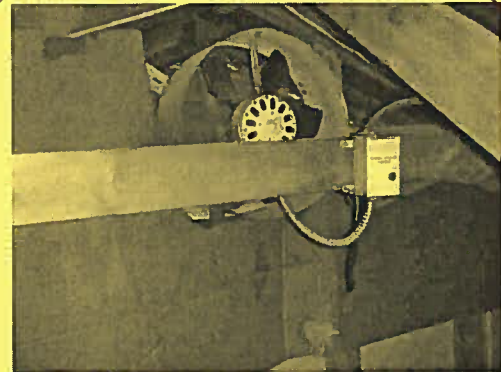
Motors are burned out in attic vent fans (both units)

Attic Fan: - Motors are burned out, both units.
9.

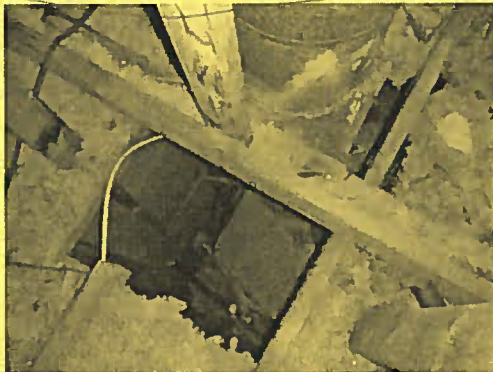
Rust on fireplace box and flue from previous leaks.  
Open area (chase) around fireplace is not sealed

Fireplace Construction: - Metal firebox and flue have areas of rust and has started rusting out in some areas.  
Visible in den and in from attic.  
A licensed contractor is recommended to further evaluate and repair.
3. Type: Wood burning
4.

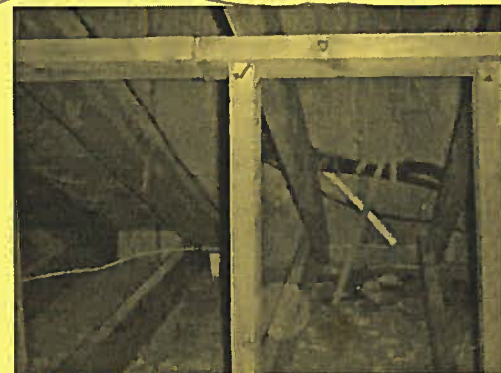
Vertical wall in sunroom is missing insulation

- \* (6) Main Attic Insulation: - No insulation present in area above back sliding door (old porch) and on vertical wall where mini split is mounted.  
Chase at chimney in attic is open/not sealed.  
A qualified contractor is recommended to evaluate and repair.
- \* (7) Main Attic Attic Fan: - Motors are burned out, both units.
- \* (8) Main Attic Moisture Penetration: - Moisture stains visible, tested dry, possibly old, confirm all leaks have been repaired.

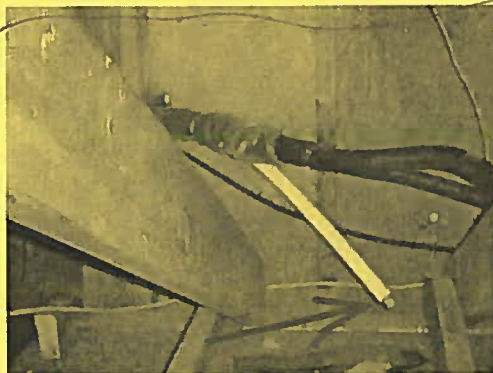
Appears installation is not complete for sunroom mini split system.

- 19. Mini Split System AC System A/C System Operation: - Installation is not complete.  
A qualified air conditioning contractor is recommended to evaluate and repair

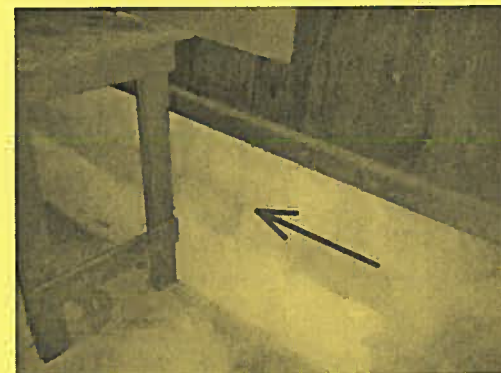
Stress crack in block wall of garage

1.      Structure Type: Wood frame
2.      Foundation: Poured - not visible
3.      Differential Movement: - Stress cracks in brick veneer above front steps, below and above back sunroom door. On L wall of garage.  
A licensed contractor or foundation company is recommended to further evaluate all of structure and repair.
4.      Bearing Walls: Frame
5.      Beams/Joists/Trusses: 2x8 or larger
6.      Piers/Posts: Block piers and steel posts
7.      Floor/Slab: Poured slab
8.      Subfloor:
