Case No. 2016-002118

City of Rock Hill, South Carolina, a Municipal Corporation, and South  
Carolina Department of Transportation, an agency of the State of South  
Carolina, Defendants,

RECORD ON APPEAL  
Volume III

| US Manhole<br><b>CB-01</b> | Total Length<br><b>149.2</b> | Material<br><b>Vitrified Clay Pipe</b> | Shape<br><b>Circular</b> | | I/I Value<br><b>N/A</b> | |

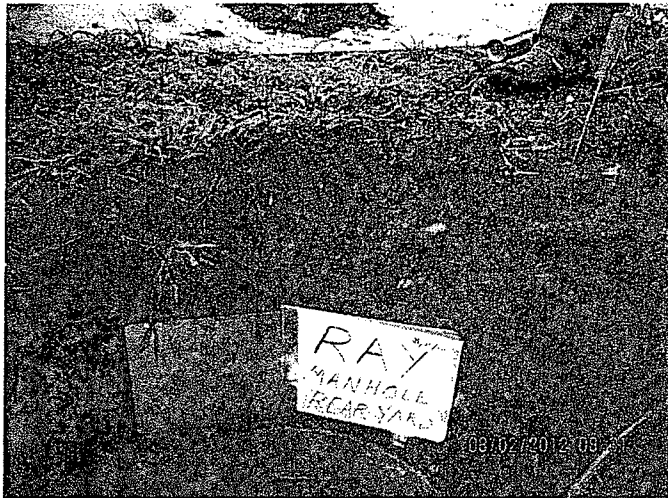
The geotechnical investigation began with removal of 2.5 feet of fill soil over the storm drain manhole lid in the rear yard. The lid was removed exposing the manhole. See Photographs 1 and 2 in the Appendix. A cracked 24" terra cotta pipe was observed entering the catch basin from the direction of the house. See Photographs 3 and 4. A 24" reinforced concrete pipe was observed leaving the catch basin to the east. See Photograph 5. A drain test was performed by Mike Leonard by placing water in the catch basin on College Avenue in front of the Ray Residence with a garden hose. See photographs 6 and 7. A few minutes later water was observed flowing through the storm drain manhole in the rear yard. See Photograph 4. Mike Leonard pointed out voids in the rear yard along the subject storm drain alignment.

**Photo 1:** Manhole in rear yard

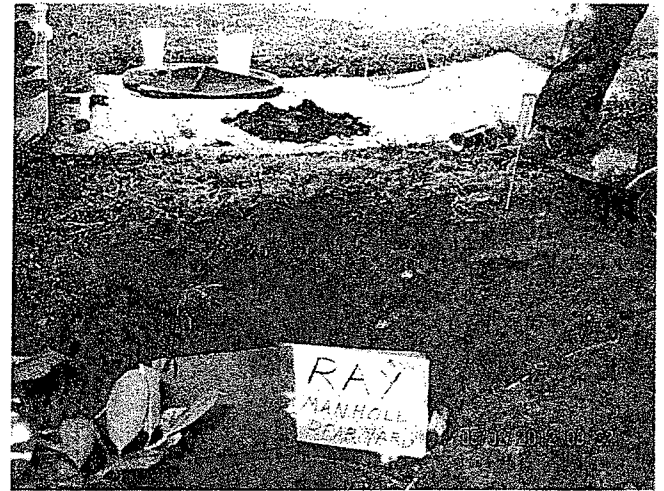
**Photo 2:** Manhole in rear yard

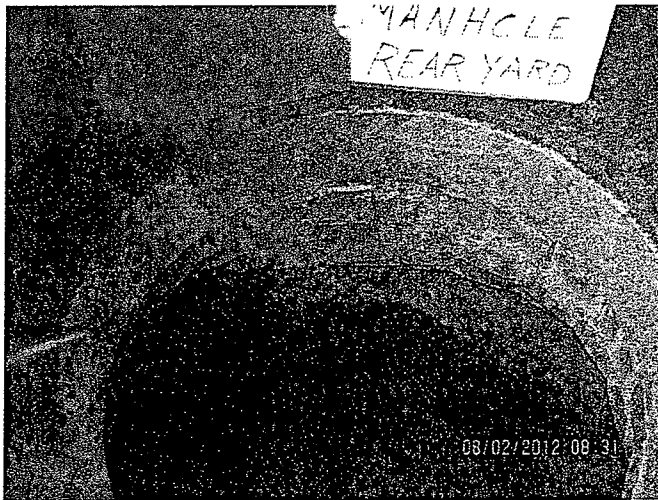
**Photo 3:** Manhole in rear yard

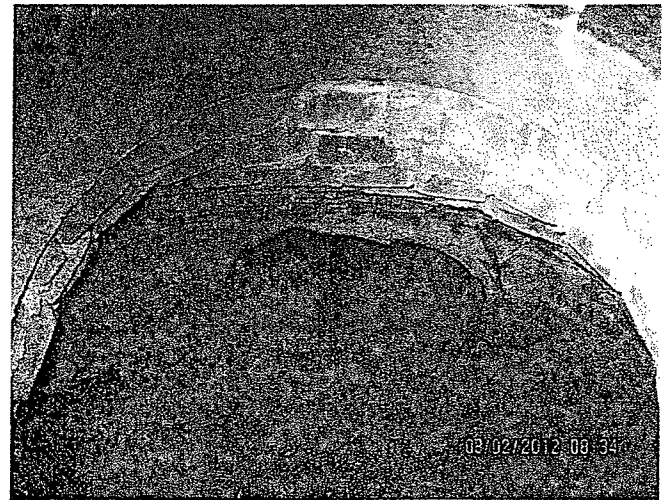
**Photo 4:** Manhole in rear yard

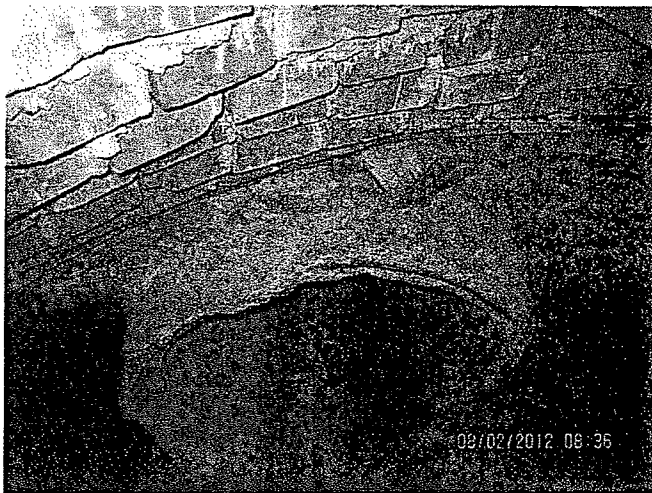
**Photo 5:** Manhole in rear yard
