THE STATE OF SOUTH CAROLINA  
In The Court of Appeals

One Belle Hall Property Owners Association, Inc., and  
Marvin T. Meek and Francis E. Hill, individually and  
on behalf of all others similarly situated,.....

Builders FirstSource-Southeast Group, LLC, .....

RECORD ON APPEAL  
VOLUME X

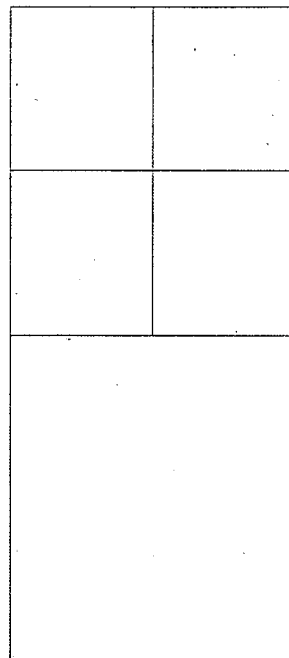
WDP OBH 12315

| Interior or Exterior Chamber | N/A | | Results:<br><br>WATER INTRUSION<br>OBSERVED 6 MIN. INTO<br>TEST AT THE HORIZONTAL<br>JOINT OF THE BACK DAM<br>NEAR THE LEFT CORNER<br>(LOCATION 1). WATER<br>WICKED TO SILL AT 17 MIN. |

LOCATION 1  
T=6MIN  
HORIZONTAL JOINT OF BACK DAM

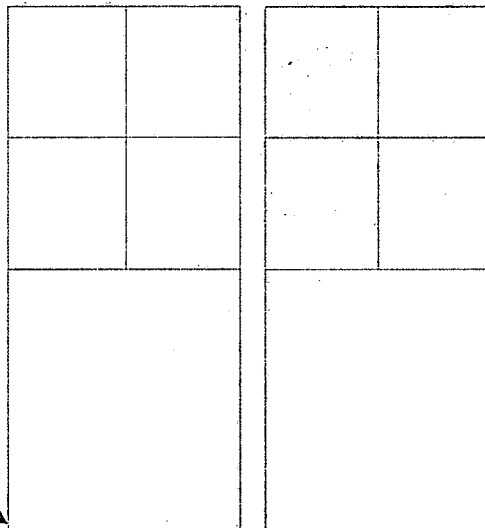
WDP OBH 12323

| Interior or Exterior Chamber | N/A | | Results:<br><br>WATER INTRUSION<br>OBSERVED 4 MIN. INTO<br>TESTING AT THE VERTICAL<br>JOINT BETWEEN BACK DAM<br>AND WINDOW FRAME<br>(LOCATION 1). WATER<br>OBSERVED 8 MIN. INTO<br>TESTING RUNNING DOWN<br>THE INTERIOR FACE OF<br>THE OSB BELOW THE<br>WINDOW (LOCATION 2). |

LOCATION 1  
T = 4 MIN.  
VERTICAL JOINT  
OF BACK DAM

LOCATION 2  
T = 8 MIN.  
INTERIOR FACE OF OSB

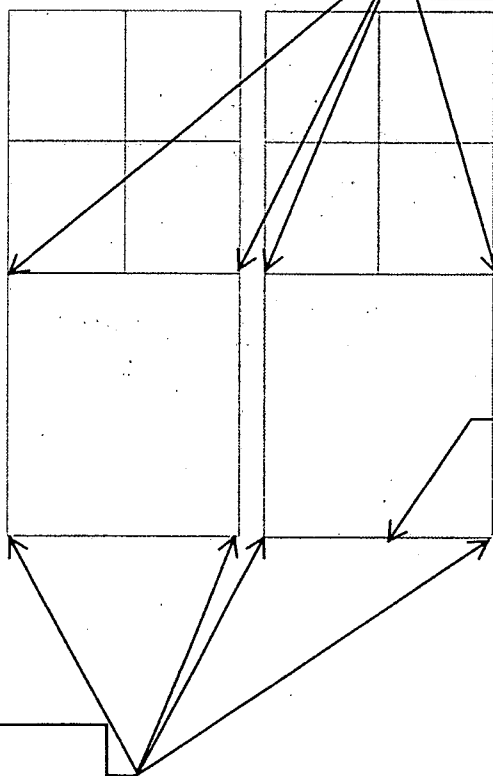
| Interior or Exterior Chamber | INTERIOR | | Results:<br><br>WATER INTRUSION OBSERVED IMMEDIATELY UPON TESTING AT THE VERTICAL JOINTS BETWEEN BACK DAMS AND WINDOW FRAME (LOCATIONS 1, 2, 3 & 4) AND STREAMING DOWN THE INSIDE FACE OF THE OSB BELOW THE WINDOW (LOCATION 5). WATER WAS OBSERVED PERCOLATING UP THROUGH ALL 4 CORNERS OF THE TWO MEETING RAILS (LOCATIONS 6, 7, 8 & 9). TEST TERMINATED AFTER 30 SECONDS DUE TO AMOUNT OF WATER INFILTRATING. |

LOCATIONS 6, 7, 8 & 9  
T = 0 SEC.  
CORNER OF MEETING RAIL

LOCATION 5  
T = 0 SEC.  
INSIDE FACE OF OSB

LOCATIONS 1, 2, 3 & 4  
T = 0 SEC.  
VERTICAL JOINT IN BACK DAM

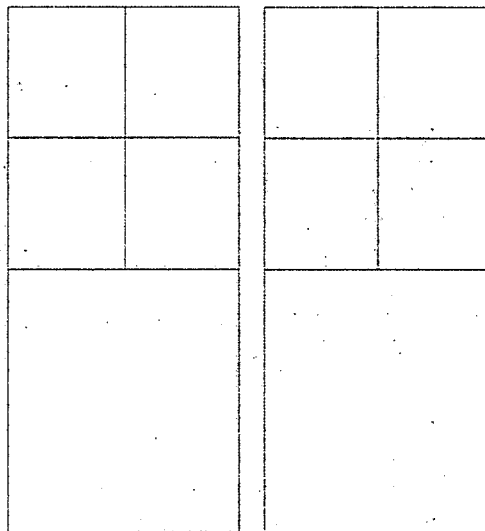
WDP OBH 12339

| Interior or Exterior Chamber | N/A | | Results:<br><br>WATER INTRUSION<br>OBSERVED 1 MIN. INTO<br>TEST AT THE VERTICAL<br>JOINT OF THE BACK DAM<br>NEAR THE RIGHT CORNER<br>(LOCATION 1). WATER<br>CONTINUED TO MIGRATE<br>INTO WALL CAVITY AT<br>JAMB. |

LOCATION 1  
T = 1 MIN.  
VERTICAL JOINT OF BACK DAM

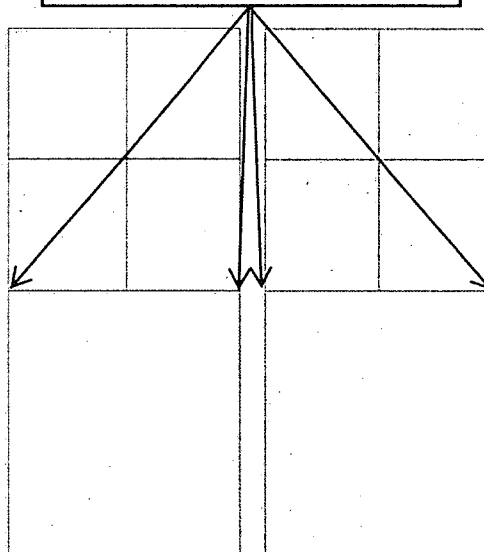
WDP OBH 12341

| Interior or Exterior Chamber | INTERIOR | | Results:<br><br>WATER INTRUSION<br>OBSERVED IMMEDIATELY<br>UPON TESTING AT THE<br>VERTICAL JOINTS OF THE<br>BACK DAMS (LOCATIONS 1<br>& 2). WATER INTRUSION<br>OBSERVED 2 MIN. INTO<br>TESTING PERCOLATING UP<br>FROM THE CORNERS OF<br>THE MEETING RAIL<br>(LOCATIONS 3, 4, 5 & 6). |

LOCATIONS 3, 4, 5 & 6  
T = 2 MIN.  
CORNERS OF MEETING RAILS

LOCATION 1  
T = 0 SEC.  
VERTICAL JOINTS OF  
BACK DAMS

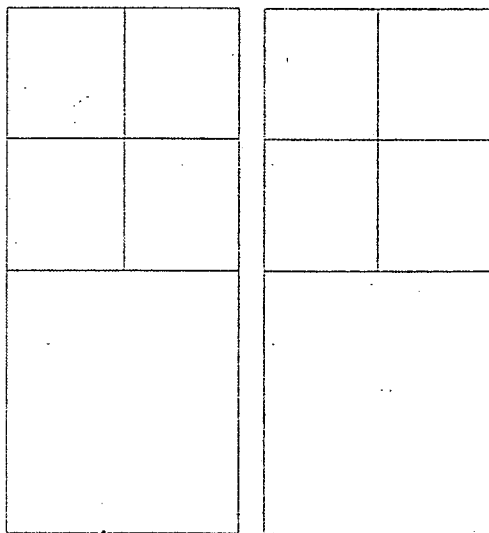
| Interior or Exterior Chamber | N/A | | Results:<br><br>WATER INTRUSION<br>OBSERVED 6 MIN. INTO TEST<br>AT THE HORIZONTAL JOINT<br>OF THE BACK DAM NEAR<br>THE RIGHT CORNER OF THE<br>LEFT WINDOW (LOCATION 1).<br>WATER INTRUSION<br>OBSERVED 17 MIN. INTO<br>TEST AT A PRE-EXISTING<br>CRACK IN THE WINDOW<br>FRAME (LOCATION 2). |

LOCATION 2  
T = 17  
WINDOW FRAME CRACK

LOCATION 1  
T = 6  
HORIZONTAL JOINT OF BACK DAM

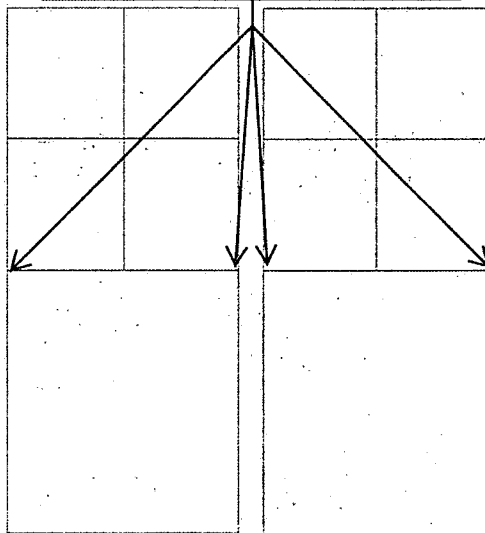
| Interior or Exterior Chamber | INTERIOR | | Results:<br><br>WATER INTRUSION OBSERVED 10 SEC. INTO TEST AT THE HORIZONTAL JOINT OF THE BACK DAM NEAR THE RIGHT CORNER OF THE LEFT WINDOW (LOCATION 1) AND AT A PRE-EXISTING CRACK IN THE WINDOW FRAME (LOCATION 2). WATER INTRUSION OBSERVED 2.5 MIN. INTO TEST PERCOLATING AT ALL 4 CORNERS OF MEETING RAILS (LOCATIONS 3, 4, 5 & 6). TESTING TERMINATED EARLY DUE TO EXCESSIVE WATER INTRUSION. |

LOCATIONS (3, 4, 5 & 6)  
T = 2.5 MIN.  
CORNERS OF MEETING RAILS

LOCATION 2  
T = 10 SEC  
CRACK IN WINDOW FRAME

LOCATION 1  
T = 10 SEC.  
HORIZONTAL JOINT OF  
BACK DAM

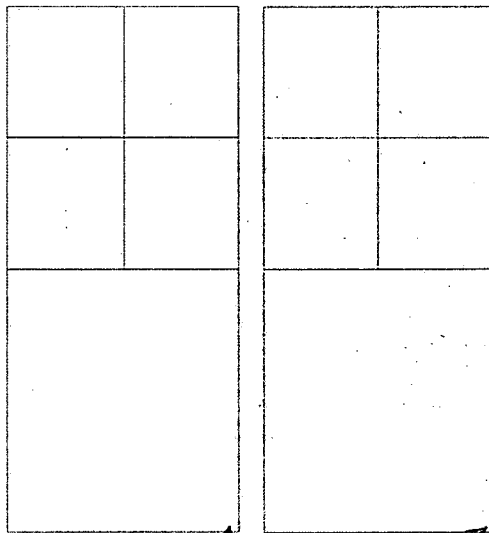
| Interior or Exterior Chamber | N/A | | Results:<br><br>WATER INTRUSION<br>OBSERVED 10 SEC. INTO<br>TEST AT THE VERTICAL<br>JOINTS OF THE BACK DAMS<br>(LOCATIONS 1 & 2). WATER<br>OBSERVED 1 MIN. INTO TEST<br>RUNNING DOWN THE<br>INTERIOR FACE OF THE OSB<br>(LOCATIONS 3 & 4). TESTING<br>TERMINATED EARLY DUE TO<br>EXCESSIVE WATER<br>INTRUSION. |

LOCATION 4  
T = 1 MIN.  
INTERIOR FACE OF OSB

LOCATIONS 1 & 2  
T = 10 SEC.  
VERTICAL JOINTS IN BACK DAMS

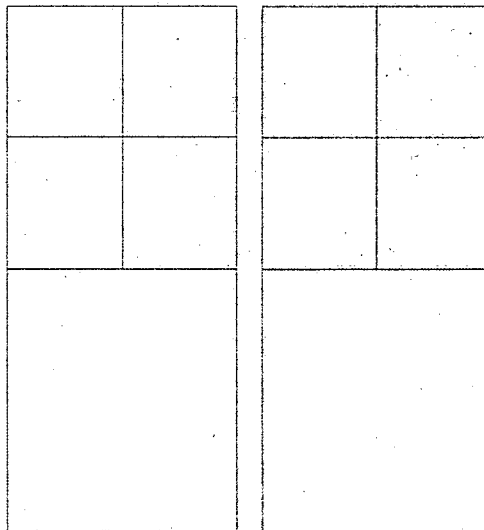
LOCATION 1  
T = 5 MIN.  
HORIZONTAL JOINT OF BACK DAM

LOCATION 2  
T = 16 MIN.  
INTERIOR FACE OF OSB

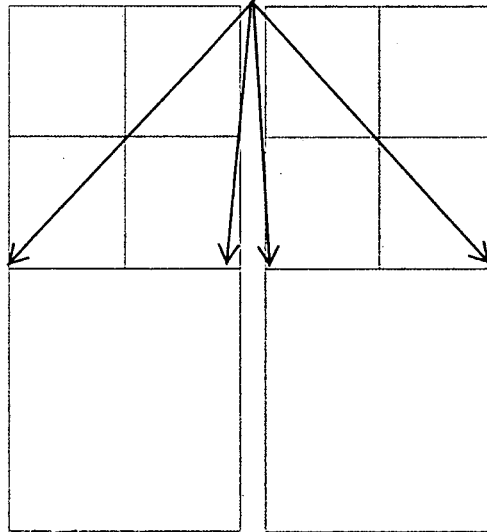
LOCATIONS 3, 4, 5 & 6  
T = 1 MIN.  
CORNERS OF MEETING RAILS

LOCATION 1  
T = 4 MIN.  
HORIZONTAL JOINT OF BACK DAM

LOCATION 2  
T = 1 MIN.  
INTERIOR FACE OF OSB

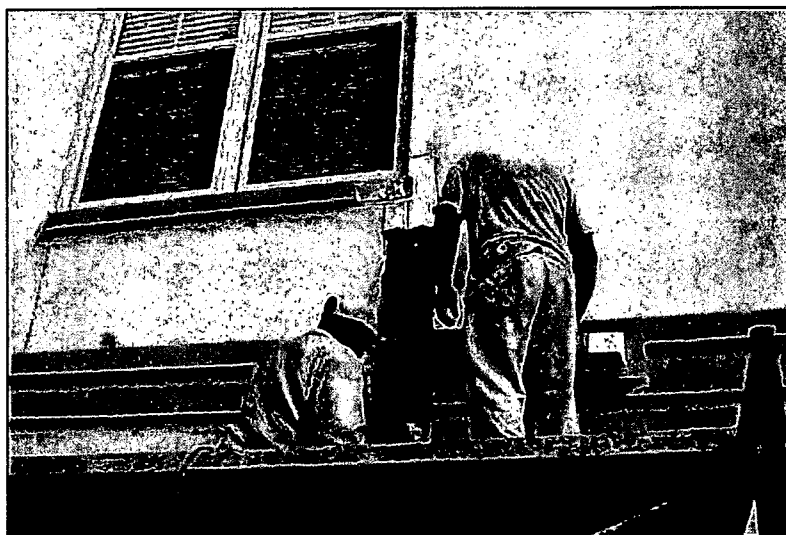
**Photograph 6**  
Note that the deterioration emanated downward from the window, and did not initiate at the decorative band (Photo by WDP).

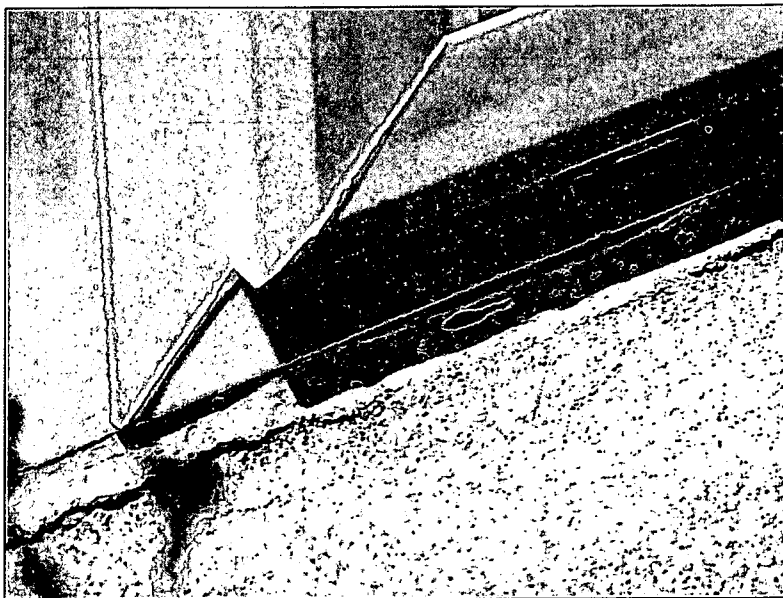
**Photograph 7**

Typical sealant joint separations (adhesive & cohesive failure).

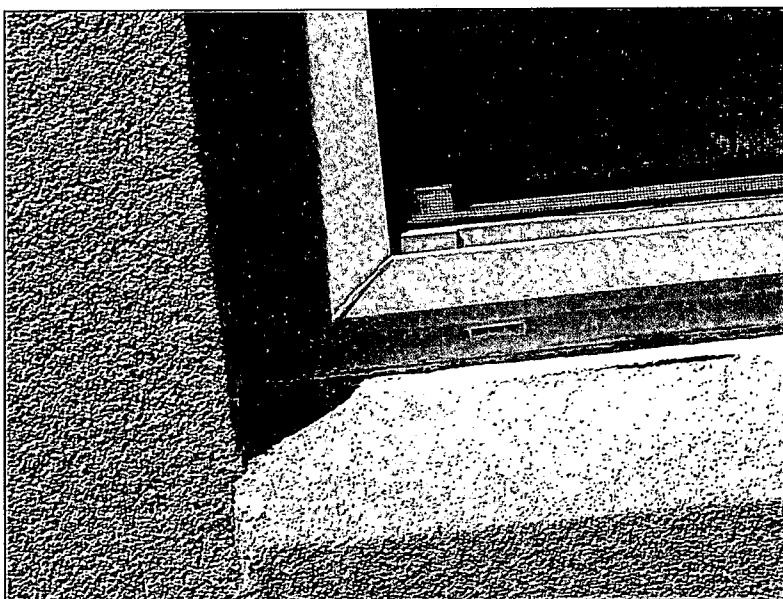
**Photograph 8**

Typical sealant joint separations (adhesive failure).

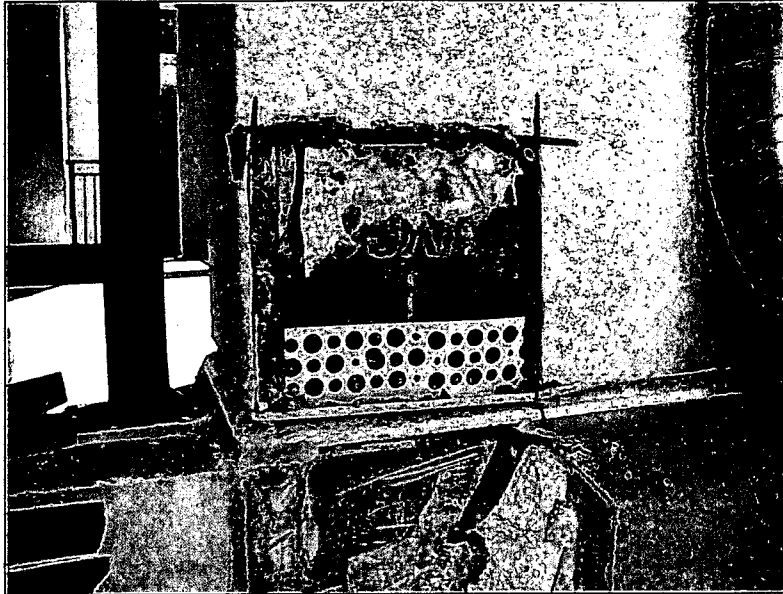
**Photograph 9**

Typical stucco flashing/WRB construction.

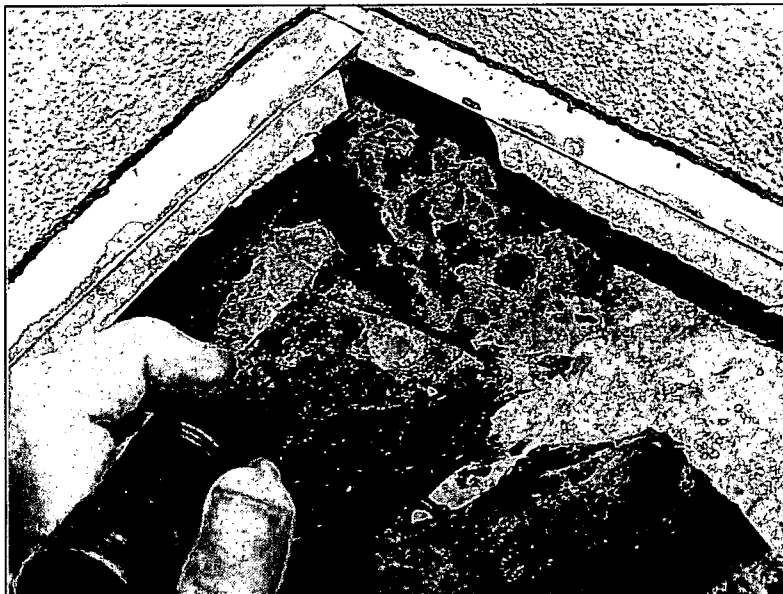
**Photograph 10**

Destructive examination at Building 2200, Unit 303. Evidence of inadequate sealing of the waterproofing membrane.

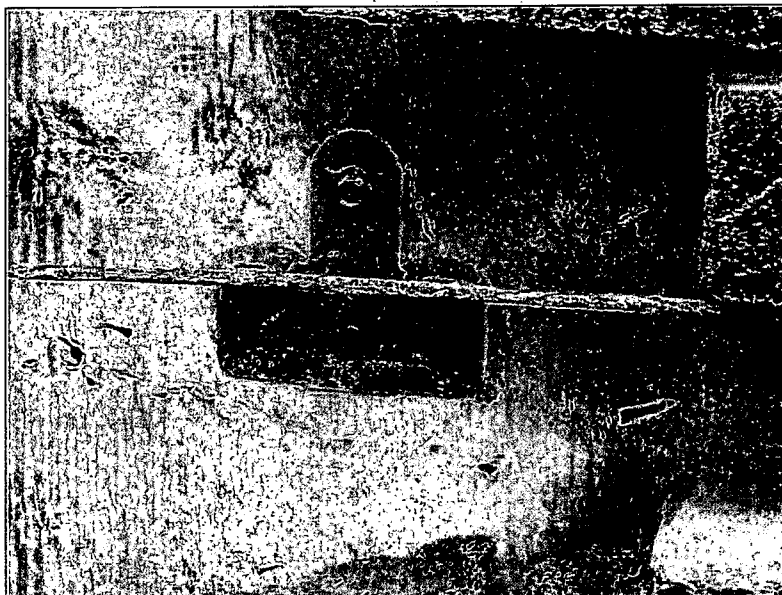
**Photograph 12**

Masonry anchors were present, but not fastened to studs (Nail inserted in lower screw hole to demonstrate).

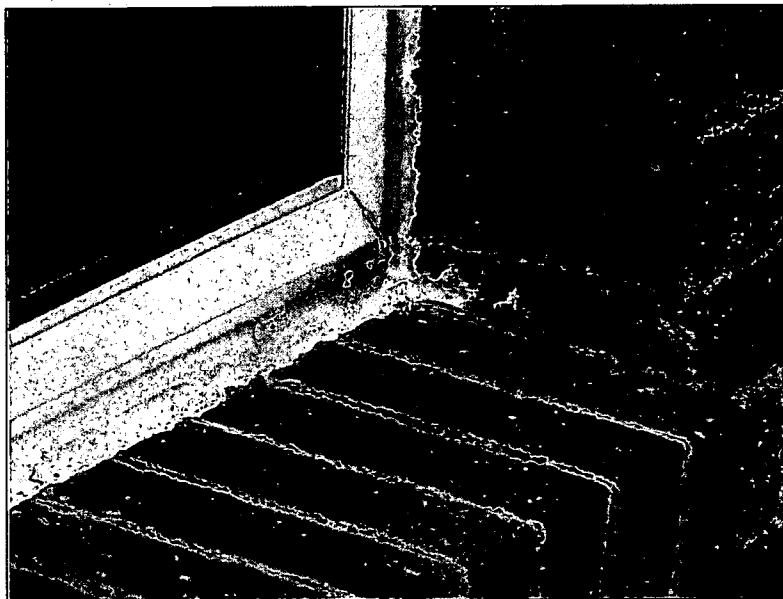
**Photograph 13**  
Typical wind-brick sealant application.

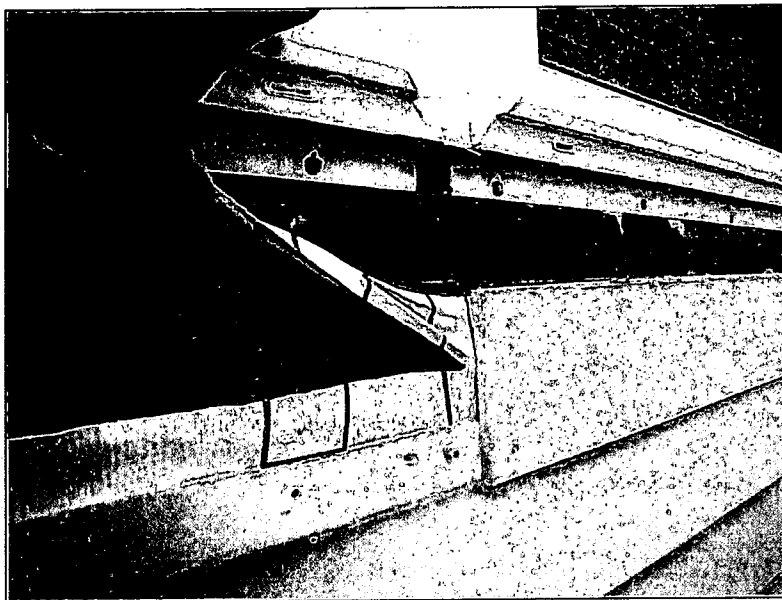
**Photograph 15**

Nails were commonly over-driven at the siding. There was no evidence of moisture damage.

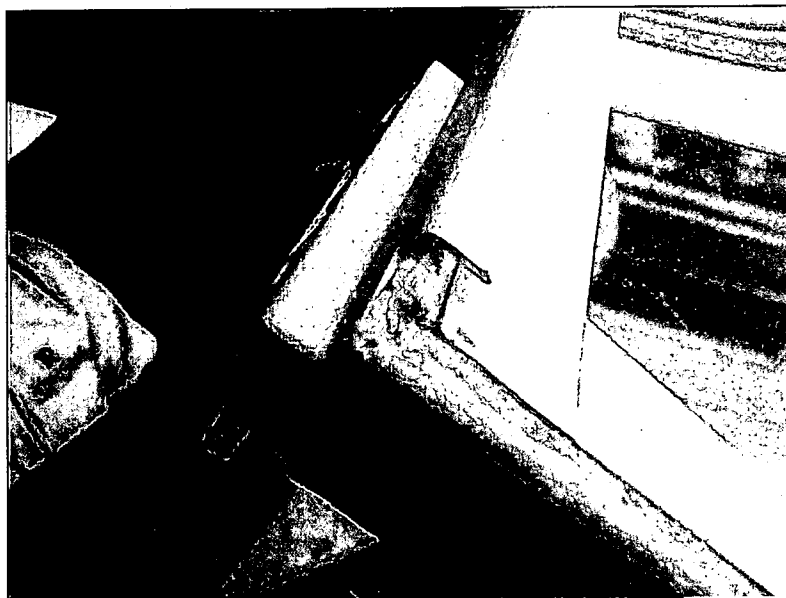
**Photograph 16**

Typical window seal wear condition.

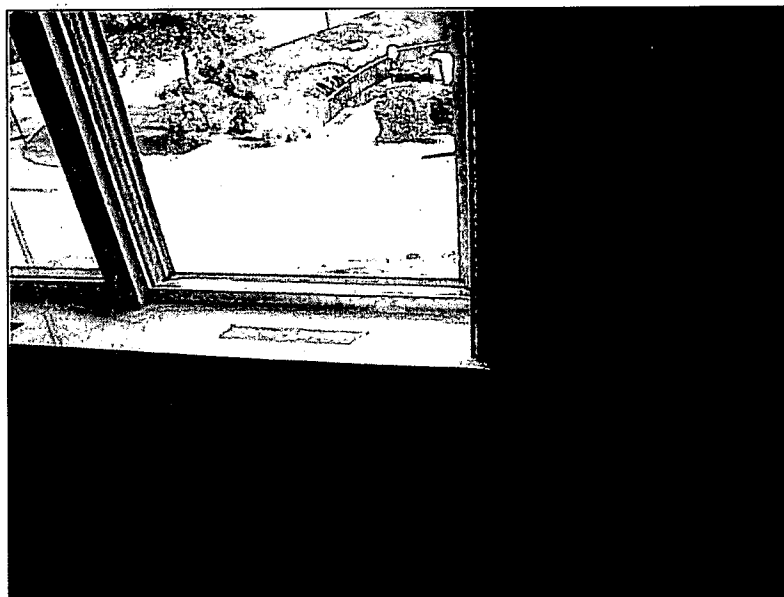
**Photograph 18**  
Typical window leak during sill dam testing (BLDG 2200, #301).

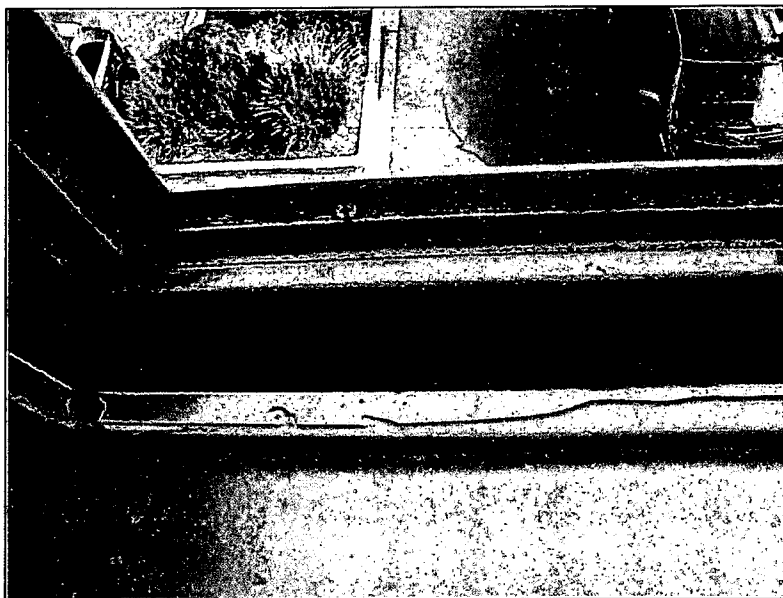
**Photograph 19**  
View of removed rear sill enclosure.

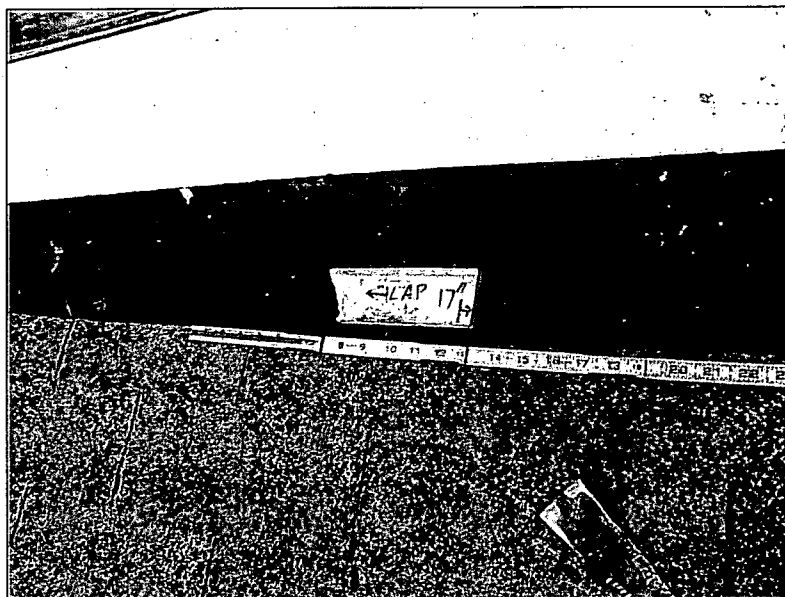
**Photograph 20**  
A 17-inch long lap at the flashing above the garage roofing.

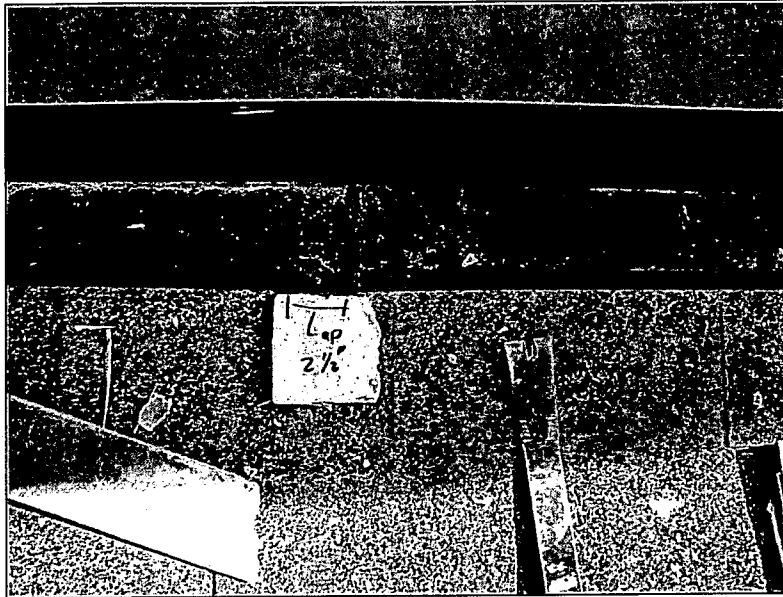
**Photograph 21**

A 2 1/2-inch long lap at the flashing above the garage roofing.

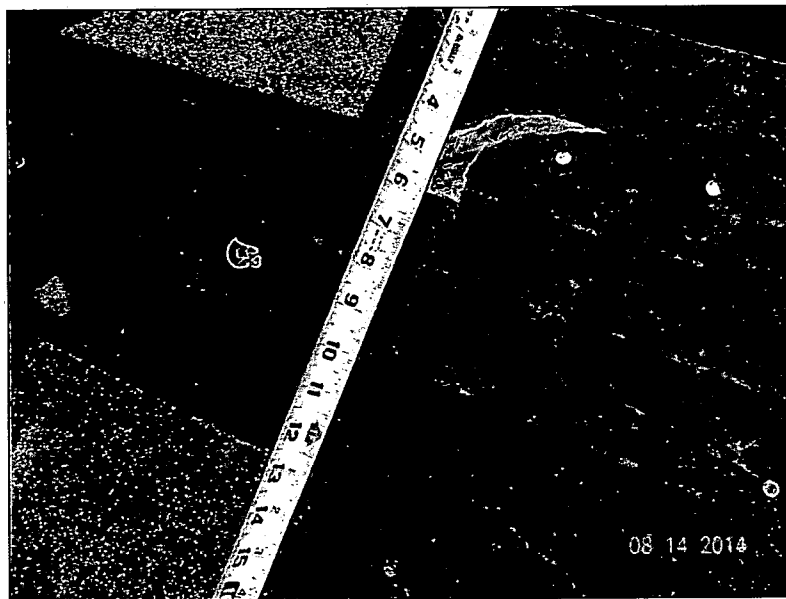
**Photograph 22**

Typical underlayment lap during inspection.

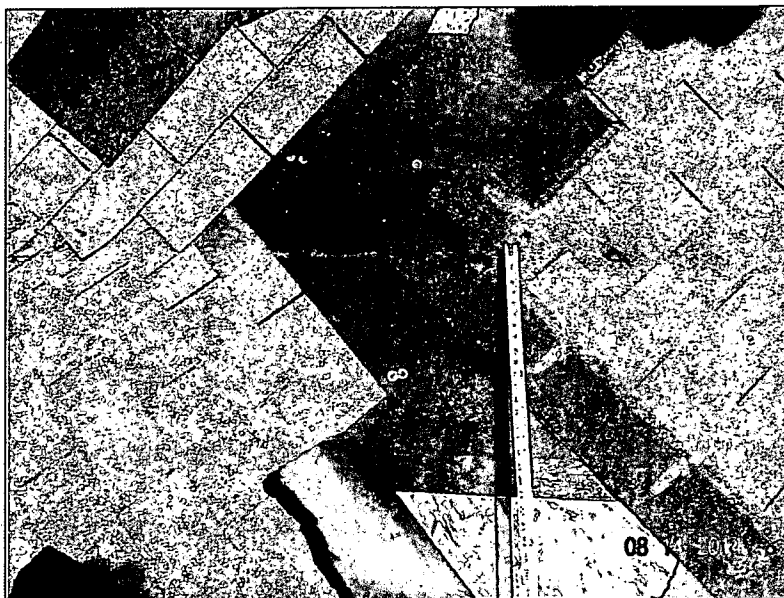
**Photograph 23**  
Typical roof valley construction.

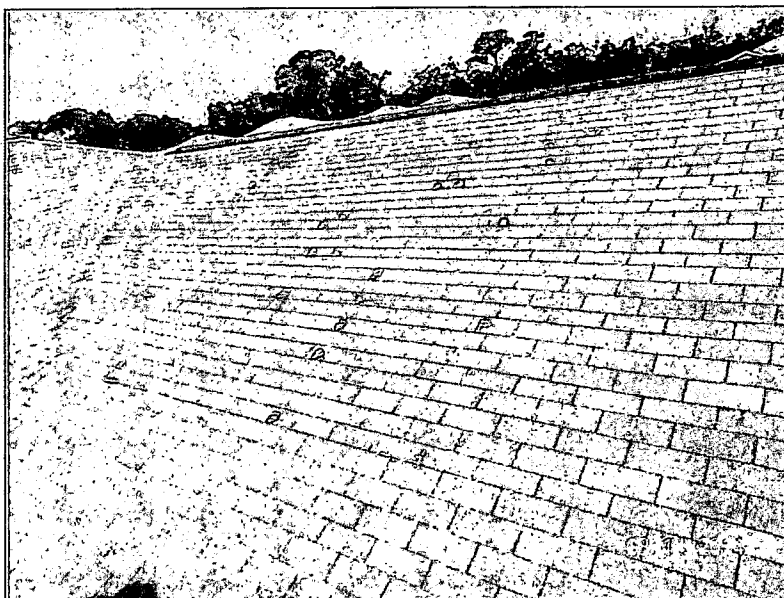
**Photograph 24**  
Randomly selected roof slope. The "B" marks indicate over-driven nails.

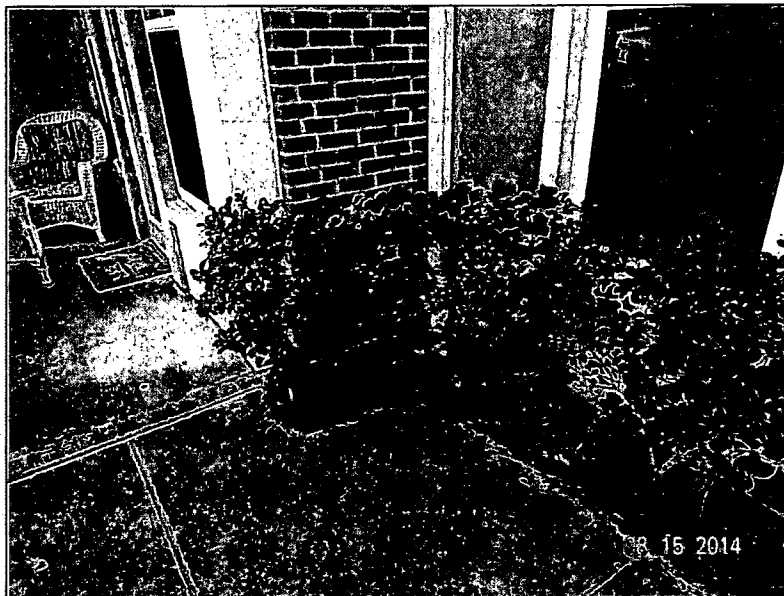
**Photograph 25**

Typical condition of the grade surrounding the buildings.

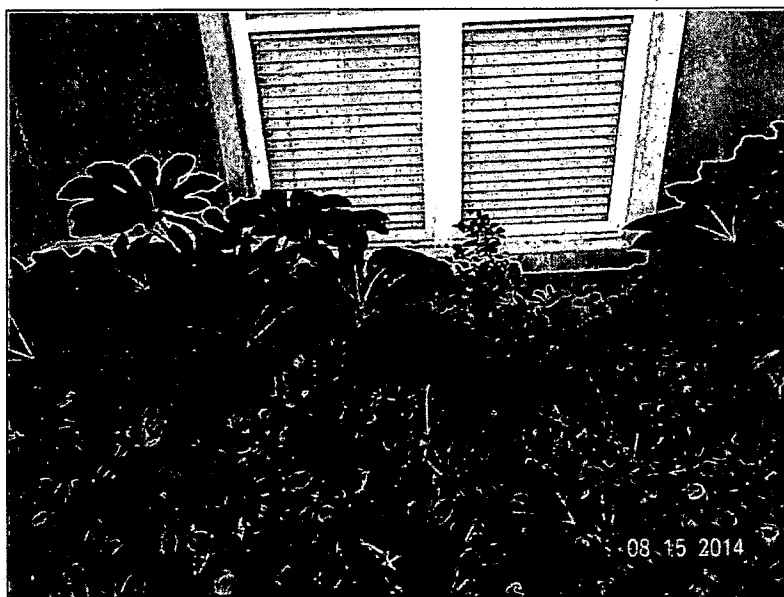
**Photograph 26**

Typical example of grade adjacent to building.

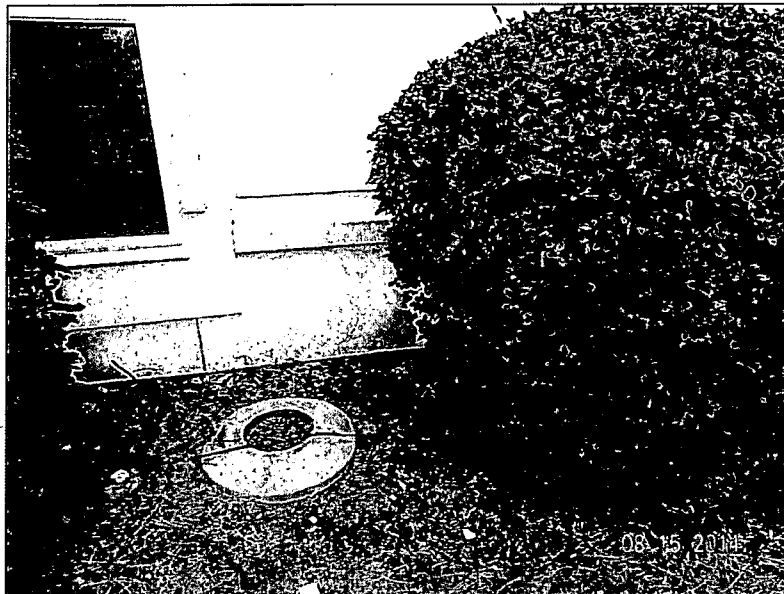
**Photograph 27**

Typical example of grade adjacent to building.

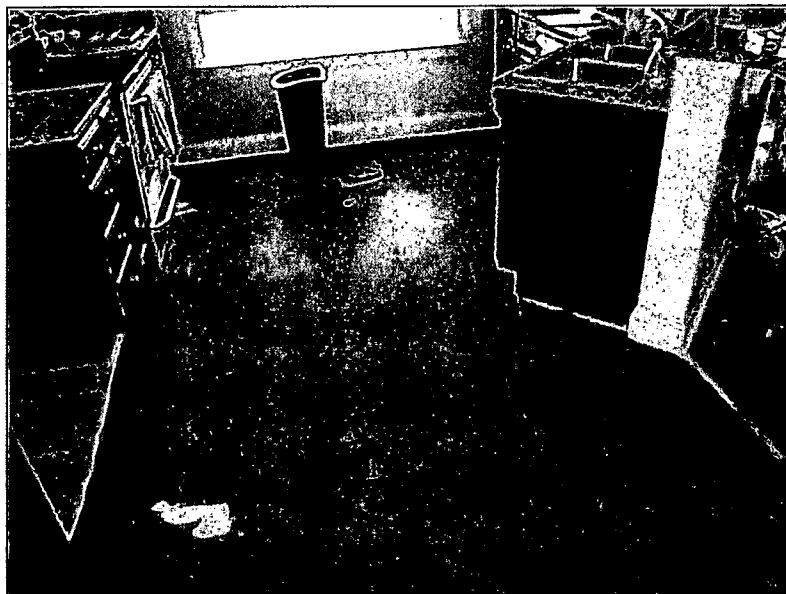
**Photograph 28**

Cracks were observed in the kitchens of some units, with tile removed from Unit 303, cracking in the gypcrete was also documented.

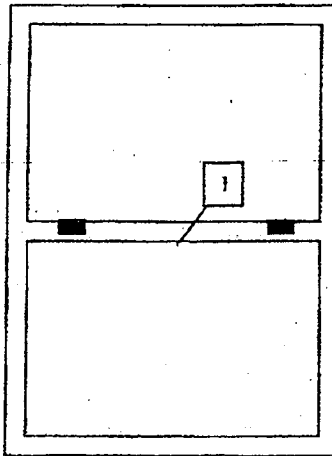
Measurement Location

Location (1) - Max. allowable Perm. Set after test load at center of sash top rail (0.4% of 45.250" span) = 0.181"

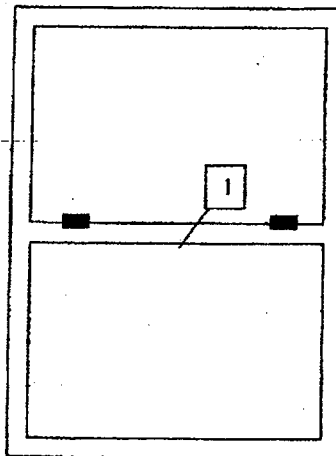
Measurement Location

Location (1) - Max. allowable Perm. Set after test load at center of sash top rail (0.4% of 45.250" span) = 0.181"
