Case No. 2016-002118

City of Rock Hill, South Carolina, a Municipal Corporation, and South  
Carolina Department of Transportation, an agency of the State of South  
Carolina, Defendants,

RECORD ON APPEAL  
Volume III

| US Manhole<br><b>CB-01</b> | Total Length<br><b>149.2</b> | Material<br><b>Vitrified Clay Pipe</b> | Shape<br><b>Circular</b> | | I/I Value<br><b>N/A</b> | |

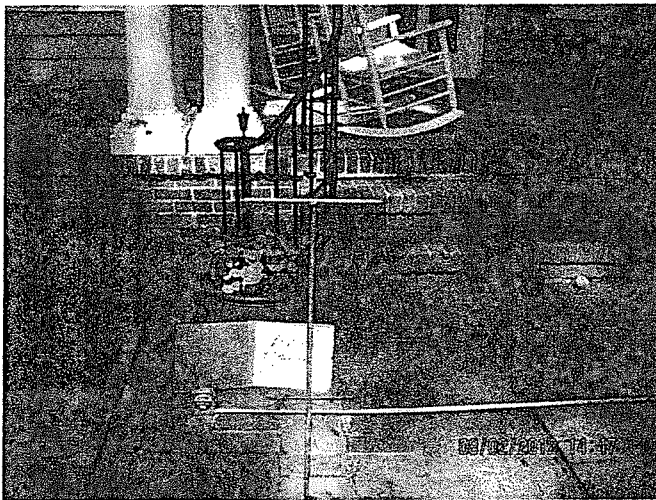
The brick sidewalk and stairs at the front of the residence have settled. Horizontal measurements indicate that the settlement is directly above the storm drain line. See Photographs 11, 12, 13, 14 and 15. The front stairs have settled approximately 1-1/8". The stairs have horizontally displaced 1-1/2" by the consolidation of the storm drain backfill soils. Michael Leonard indicated that he observed in the attic separation in the front porch framing members. Ms. Ray understood the former owner had replaced the brick front stairs prior to 1985.

Photo 11: Front sidewalk and steps - Probe rod represents measured alignment of storm drain line.

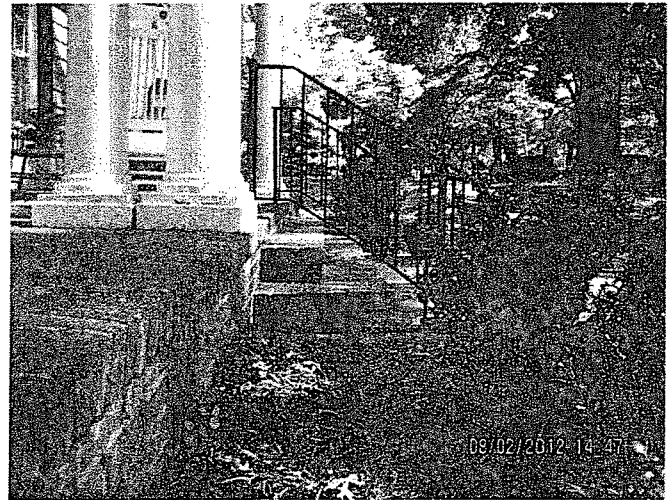
Photo 12: Front sidewalk and steps

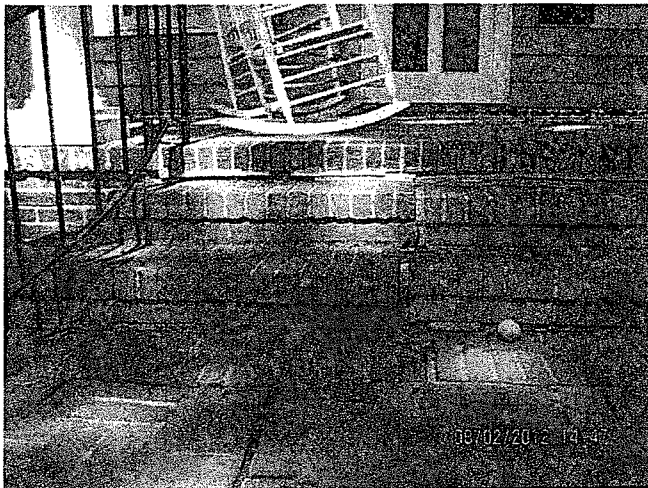
**Photo 13:** Front sidewalk and steps
